This Service Information bulletin supersedes SI B16 03 10 **dated March 2010**.

"Exhaust Fluid Low" Warning Displayed Before Oil Service

E70 and E90 with M57Y engine

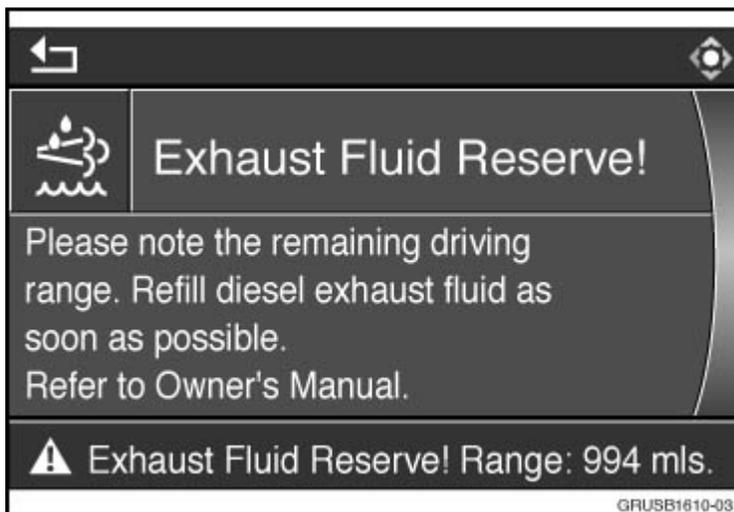
The customer receives a warning message stating that the diesel exhaust fluid level is low, and the engine will not restart in 999 miles or less. The warning comes a few thousand miles prior to the recommended oil service being due.
