Rattle from Panoramic Roof when Fully Open

E83 (X3)

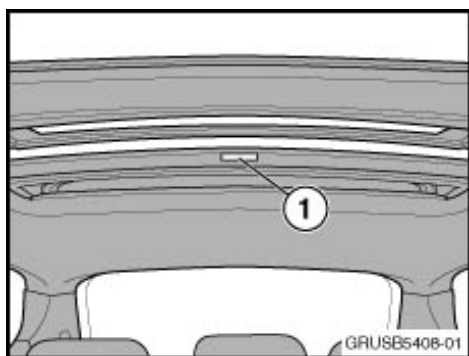
1. The front sunroof glass panel contacts the bottom of the rear rain gutter.
2. The lower rear edge of the rear glass panel vibrates against the top of the rear rain gutter.

2. Visually inspect the underside of the rear rain gutter to determine whether a felt pad (1) is already present. If it is not present, place three 30mm pieces of felt tape front-to-back to create an approximately 30x50mm pad on the underside of the rear rain gutter.
