This Service Information bulletin supersedes S.I. 12 10 99 **dated May 1999** which should be removed and discarded from your S.I. binder.

SUBJECT: Voluntary Emissions Recall Campaign No. 99E-A01

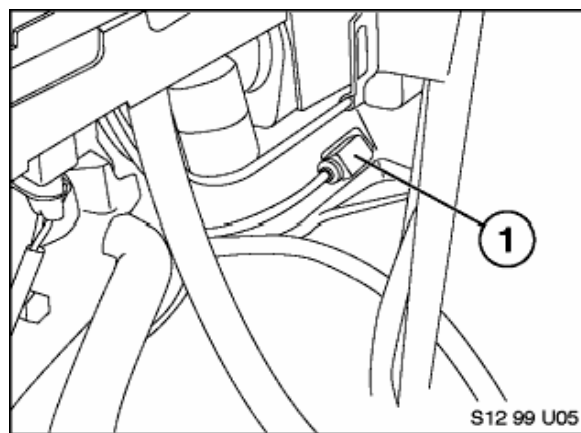
1. Remove the crankshaft position sensor which is located below the starter motor.

Remove the Sensor (1)

If the sensor currently installed in the vehicle has a connector directly on the sensor which can be disconnected, then the new sensor is already installed. No further action is required and the DCS contact can be closed.

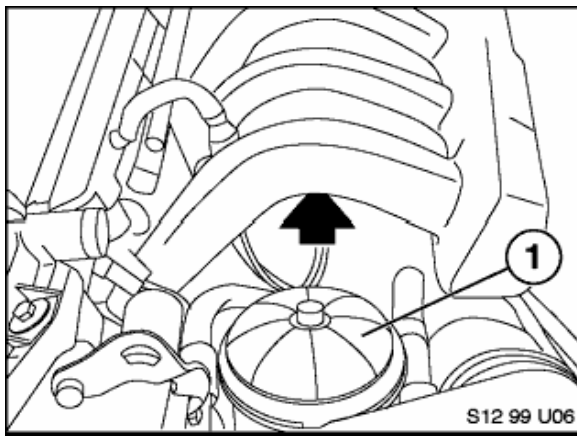
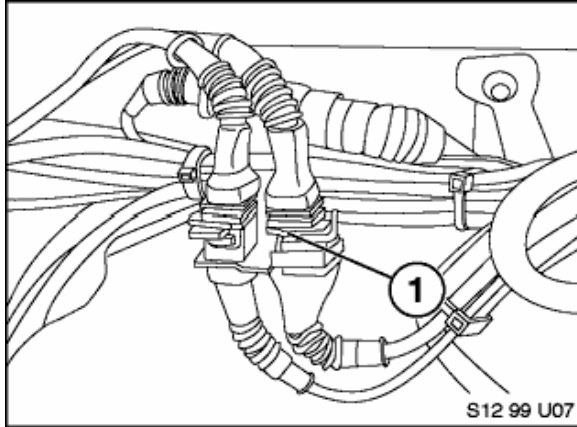
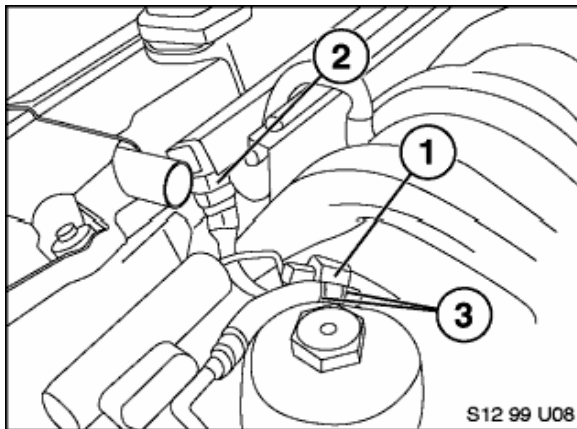
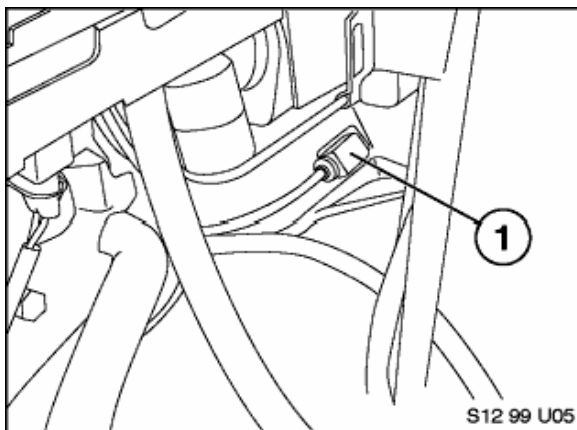
2. The electrical connection of the crankshaft sensor to the engine harness is located below the intake manifold.

3. Disconnect the crankshaft position sensor (1) from the engine harness.

Note: This illustration shows the plug connectors with the intake manifold removed. **It is not necessary to remove the intake manifold in order to gain access to these connectors and complete this repair.**

To access this connector, the cap of the oil filter housing (should be removed and the oil filter and housing should then be covered to prevent dirt from getting onto the oil filter.

4. Remove the fuel rail cover and unplug the VANOS solenoid valve plug connector (2).

5. Install the new crankshaft position sensor (1) P/N 12 14 1 709 616 and O-ring P/N 12 14 1 748 398.
