## SUBJECT

### Vibration at Idle

E60 with N52K

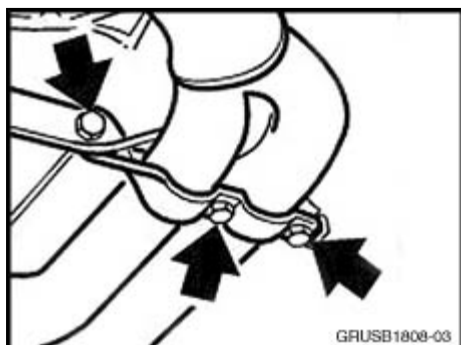
1. Verify the complaint. Vibration/droning is most prevalent when engine is at operating temperature.
