BMW E39 Expansion Tank Failure Analysis

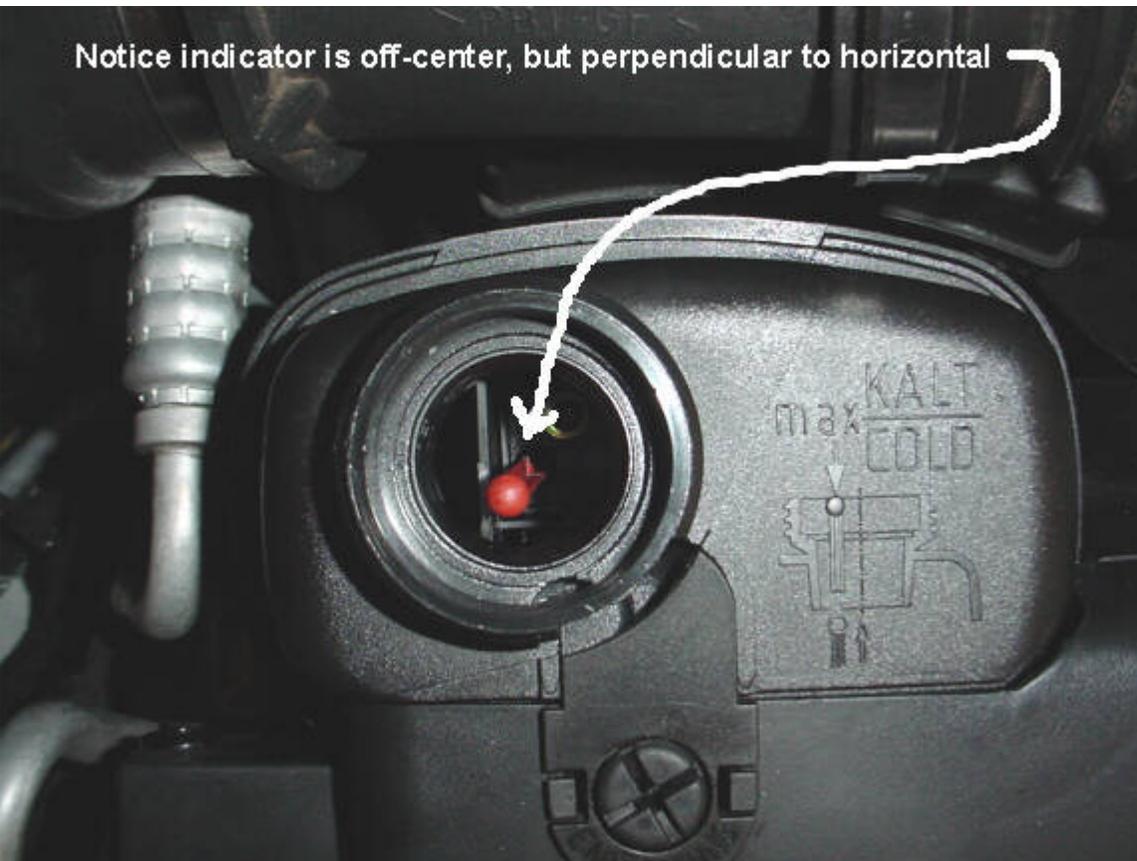
Notice indicator is off-center, but perpendicular to horizontal

Here's the new tank with the cap (not included) removed. As you know, the red indicator should be even with the top of the tank when the motor is cold.

Although it is off-center in the opening, it should be sticking STRAIGHT up. Mine has always sort of leaned over to this side or that, and I just assumed the float was tilted - no big deal, right?

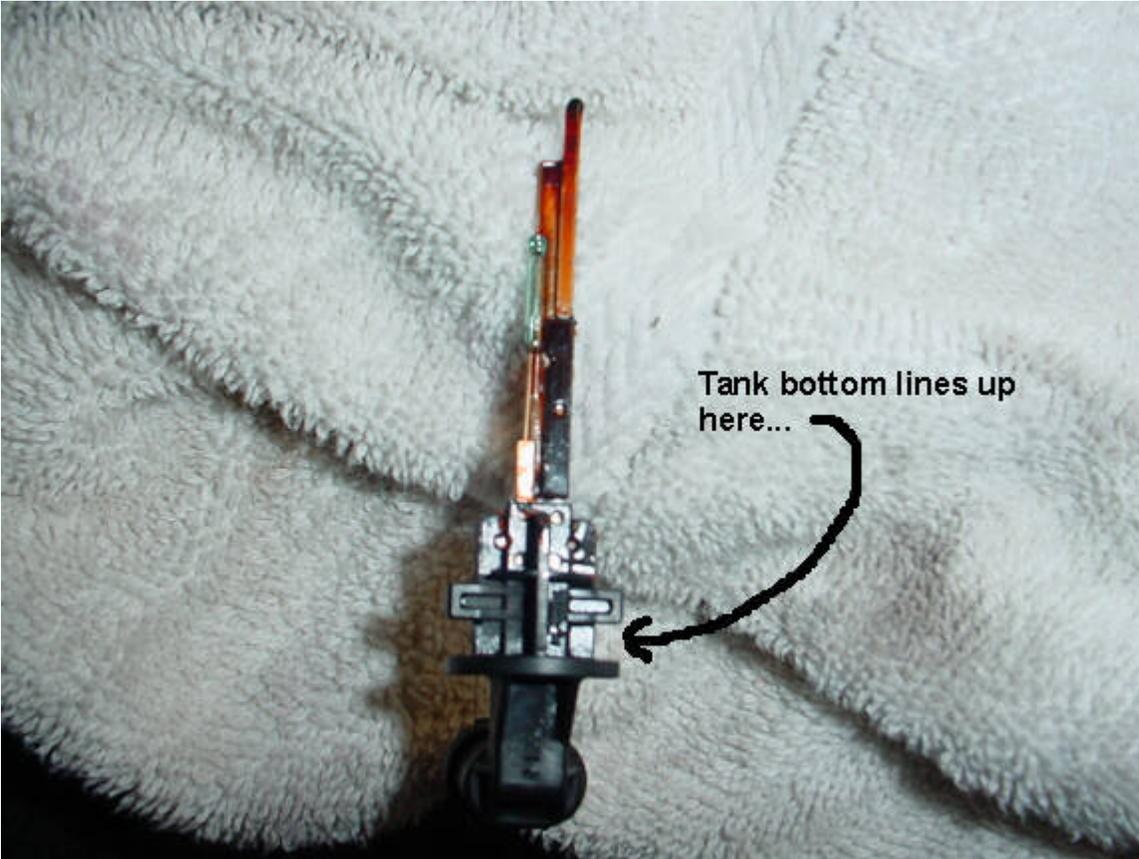
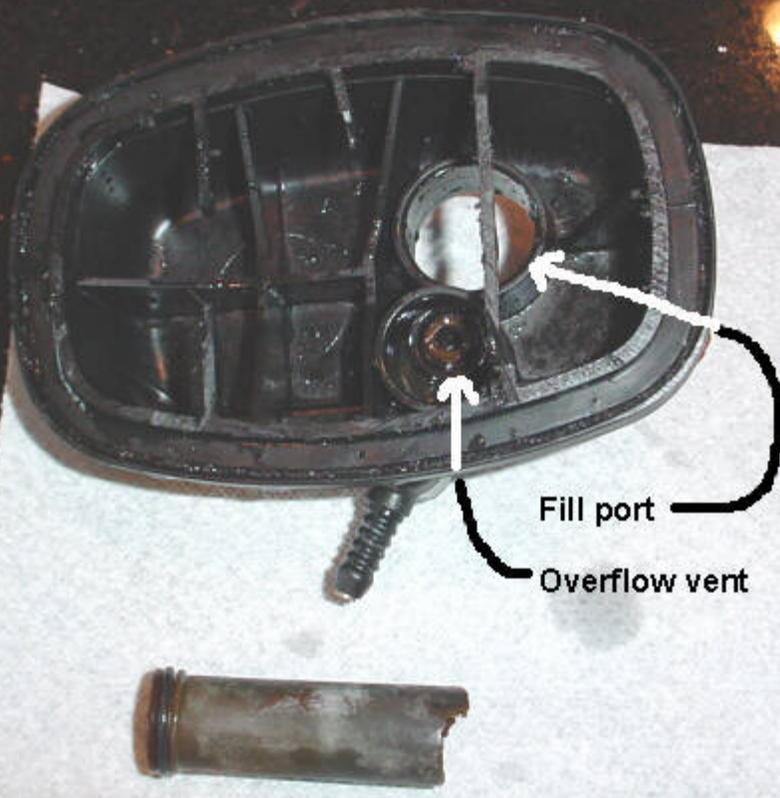
Here's a picture of the sensor which is installed in the bottom of the tank. The "inside" portion of the sensor is about 1-1/2 inches long. When I discovered the leak, I assumed this to be a wet sensor, and couldn't figure out how it was supposed to seal against the bottom of the tank.

As it turns out, this is *not* a wet sensor - it fits into a cavity molded into the tank bottom, which in turn protrudes up into the tank proper. This cavity is sealed from the coolant, and is supposed to be dry.

I am fairly sure this sensor works as follows: the coolant level float in the tank contains a metallic "donut", and this sensor must use this (via magnetic field, Hall Effect or ???) to determine the proximity of the float to the sensor. When the coolant level gets low, the float gets closer and closer to the sensor, until the low-coolant alert is triggered...

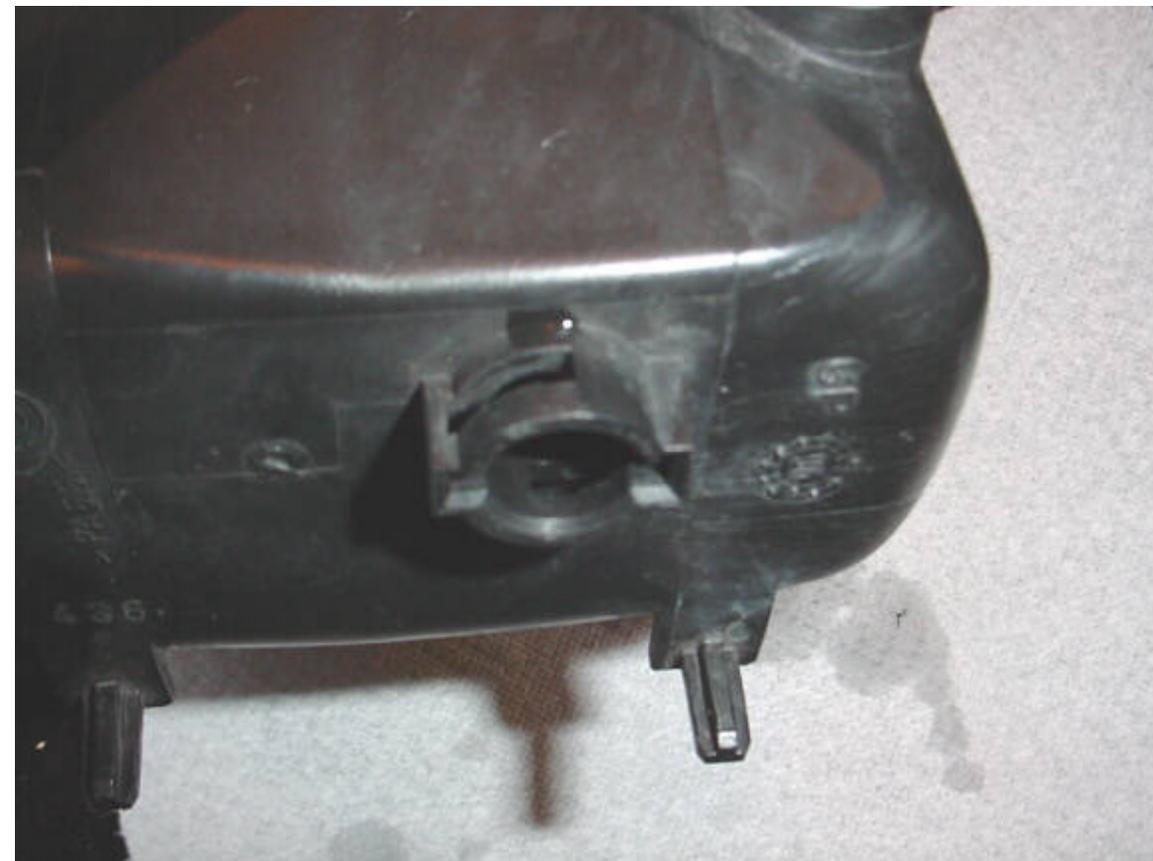
Here's the other side of the tank - looking at the bottom from the outside. You can see the sensor cavity molded into the tank, and the hole at the top (same hole as in previous pic).

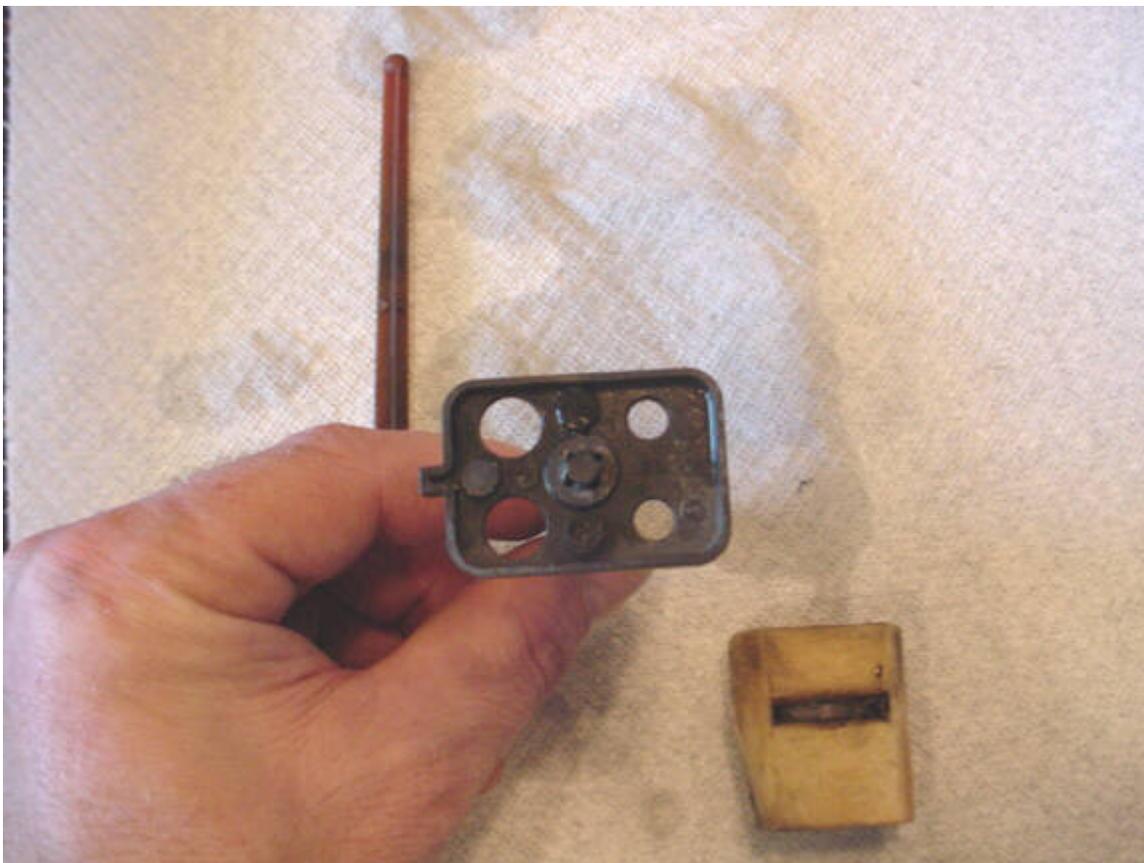
Here's how the float assembly came out after cutting open the tank. Note that the act of cutting the tank did nothing to these pieces.

Looking at the "T" shaped support, you can see that it basically forms a large moment arm acting on the very small portion of tank it gets glued to.

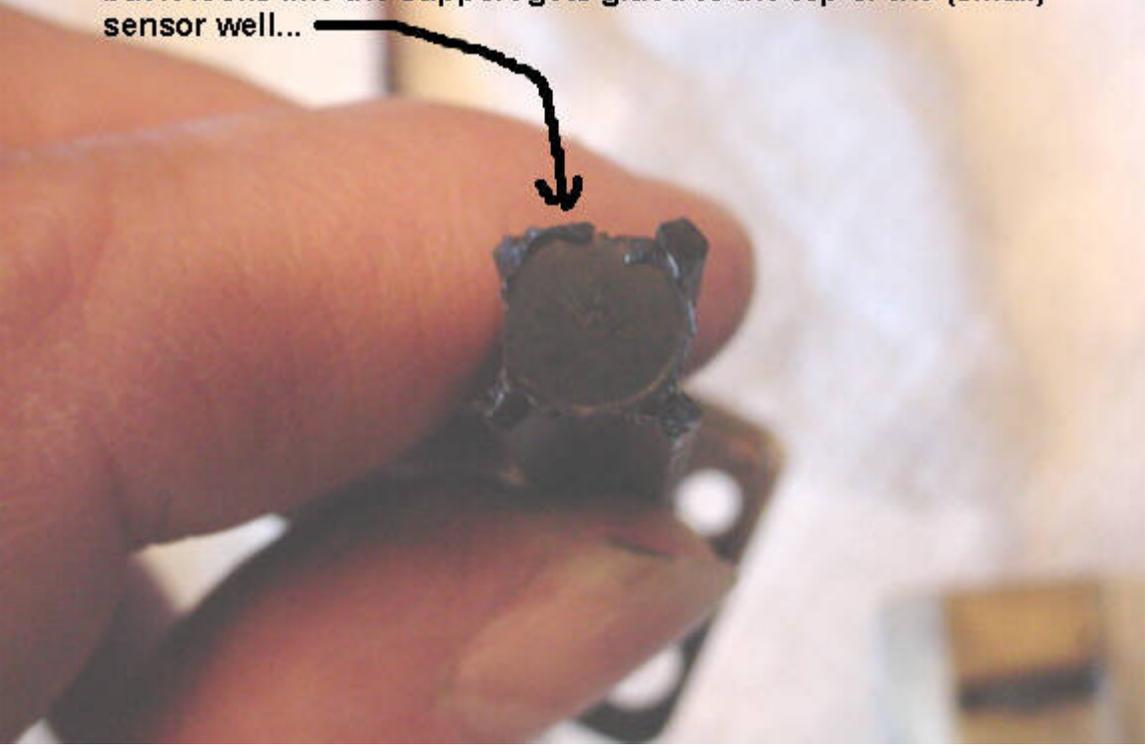
Here's the top of the support, which you can see when you look down inside your expansion tank. The red indicator sticks up through one of these holes. This rectangular platform sits down in the tank, held in place by guides molded into the tank.

This is actually part of the bottom of the tank! I can't tell for sure, but it looks like the support gets glued to the top of the (small) sensor well...

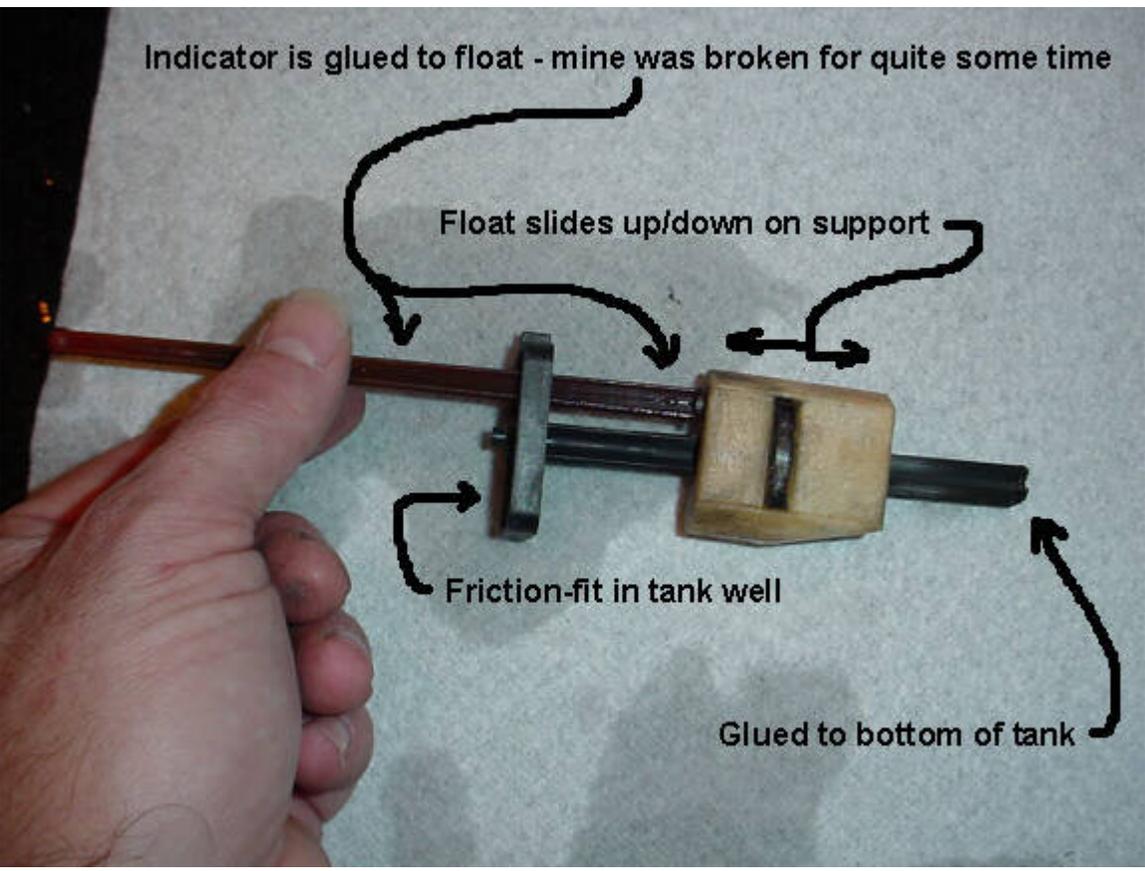
The other end of the support. you can see how small the section is that gets attached to (and forms part of!) the tank floor.

Indicator is glued to float - mine was broken for quite some time

Float slides up/down on support

Friction-fit in tank well

Glued to bottom of tank

Now we get to my theory. This shows how the float assembly should look. The float and indicator are supposed to be one piece. The float slides up and down on the support. Note the metallic piece embedded in the float.

But, if you happen to replace the expansion tank cap in such a way that the indicator is cocked to one side (instead of carefully placing it straight down on the indicator), over time it can (and does) break off and separate from the float. Now you have an even longer lever arm working against that small section at the bottom of the tank.

Eventually the bottom of the tank fatigues and develops a crack, and coolant is then free to leak past the sensor. On my tank, the support had broken completely away. Bad design, Hans...
