Before we get in to how to change the Timing Chain (TC) tensioner on an N20 motor, a little background is in order. As far as I can tell, BMW has used at least three different versions of the tensioner with following part numbers:

These tensioners are common to many (all 4-cyl engines?) models across the BMW model lineup. My car is an X4 (F26) built in 8/2014, so it was built with 2) above.

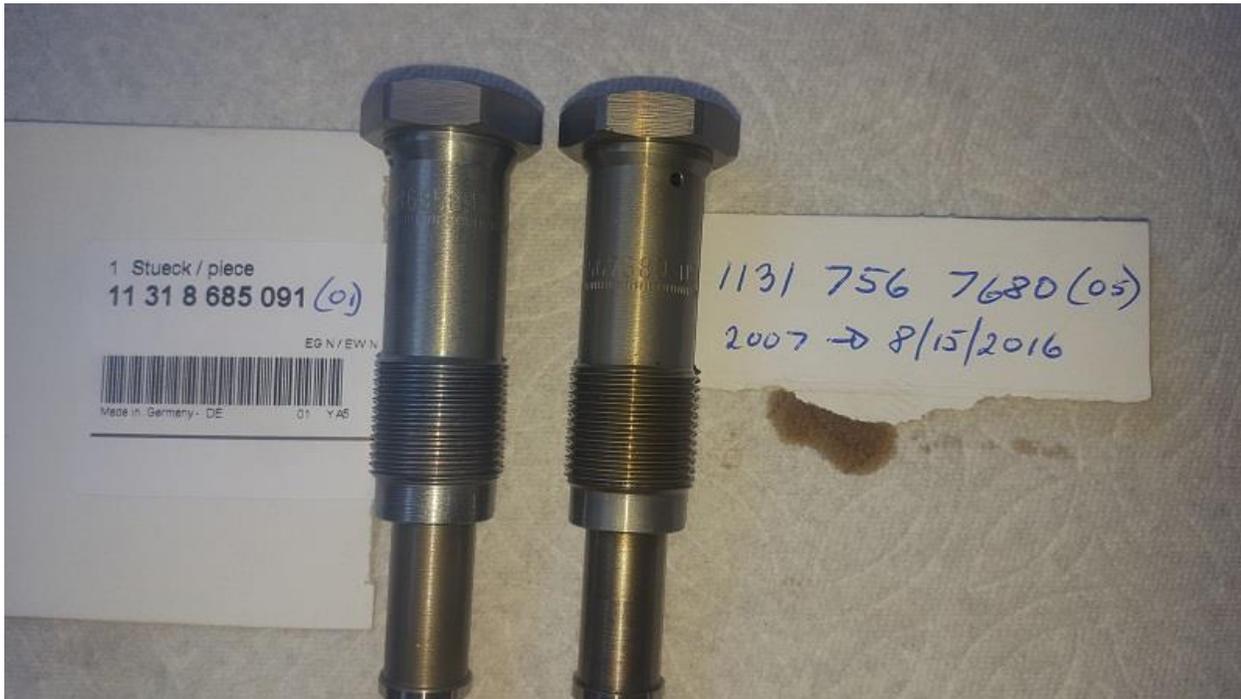
- The spring on 3) is much stiffer than on 2)
- The holes near the head are position differently. On 3) they are placed closer to the head of the bolt where the bolt tapers up to the head. The holes are also slightly larger.
- The top of the head of the bolt looks different and 3) has a colored dot on it.

New one (1131 8 685 091) on the left – old one (1131 756 7680) on the right.

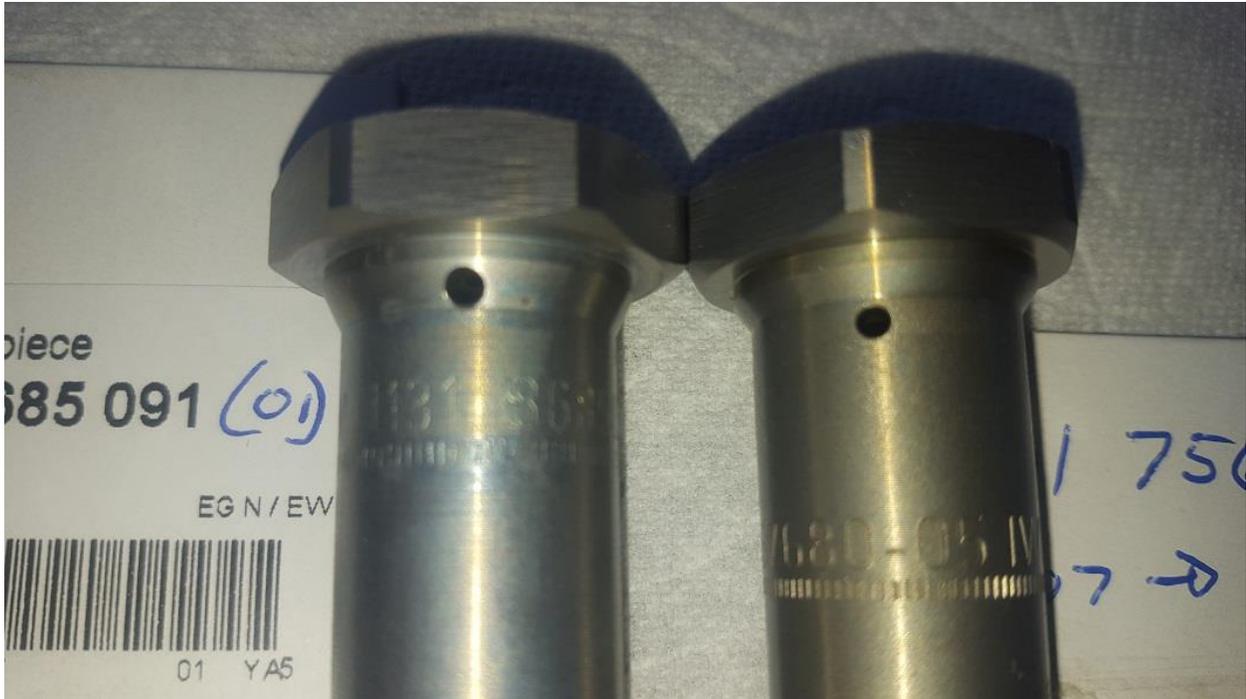
Hole on new (left) is bigger and position differently.

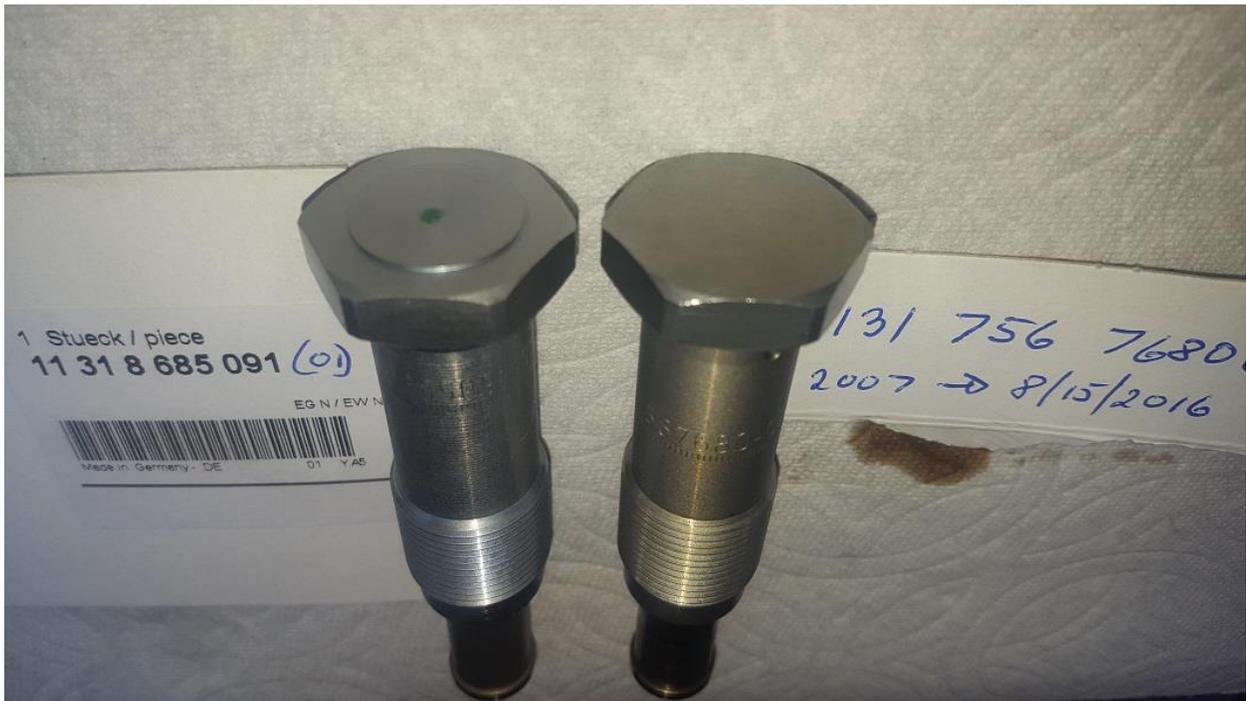
New one (left) has a green dot which would be visible when installed.

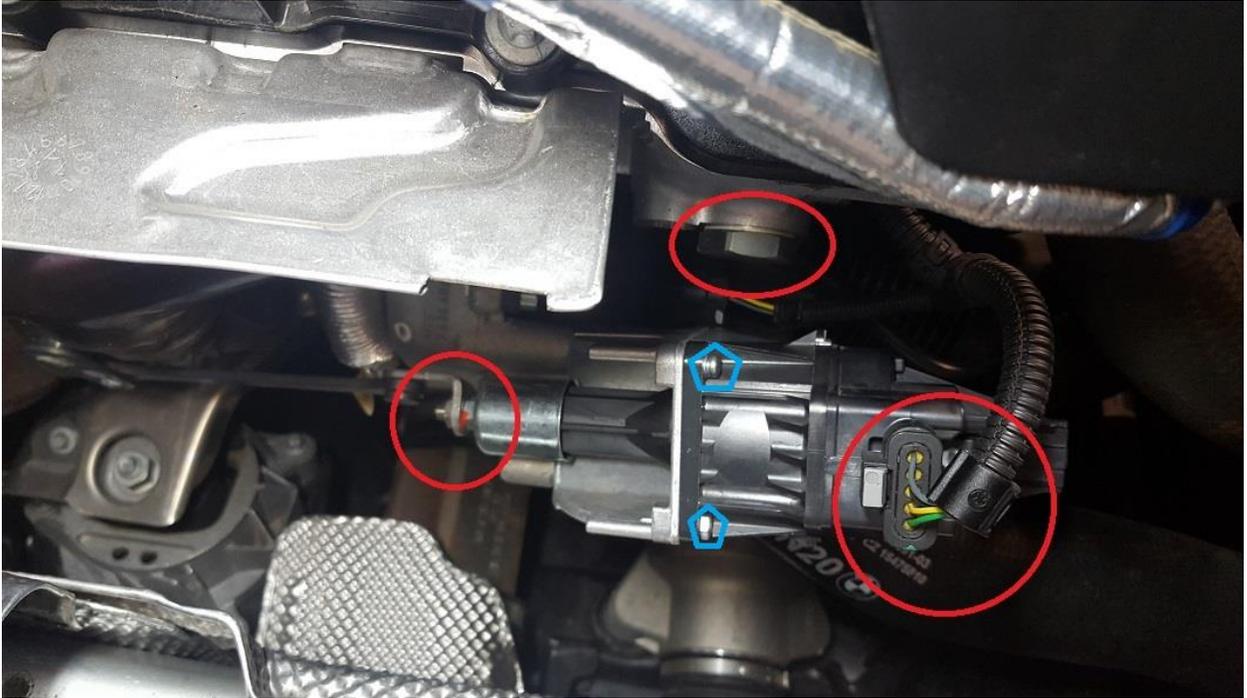
In the picture below, the top red oval is the actual tensioner – a 27mm “bolt”. The red circle to the left is the linkage to the waste gate(?) – a 10mm nut. The red circle to the right covers the electrical connection. Finally, the blue shape indicates two of the four Philips screws. The other two are below in the corners of the black plastic body.

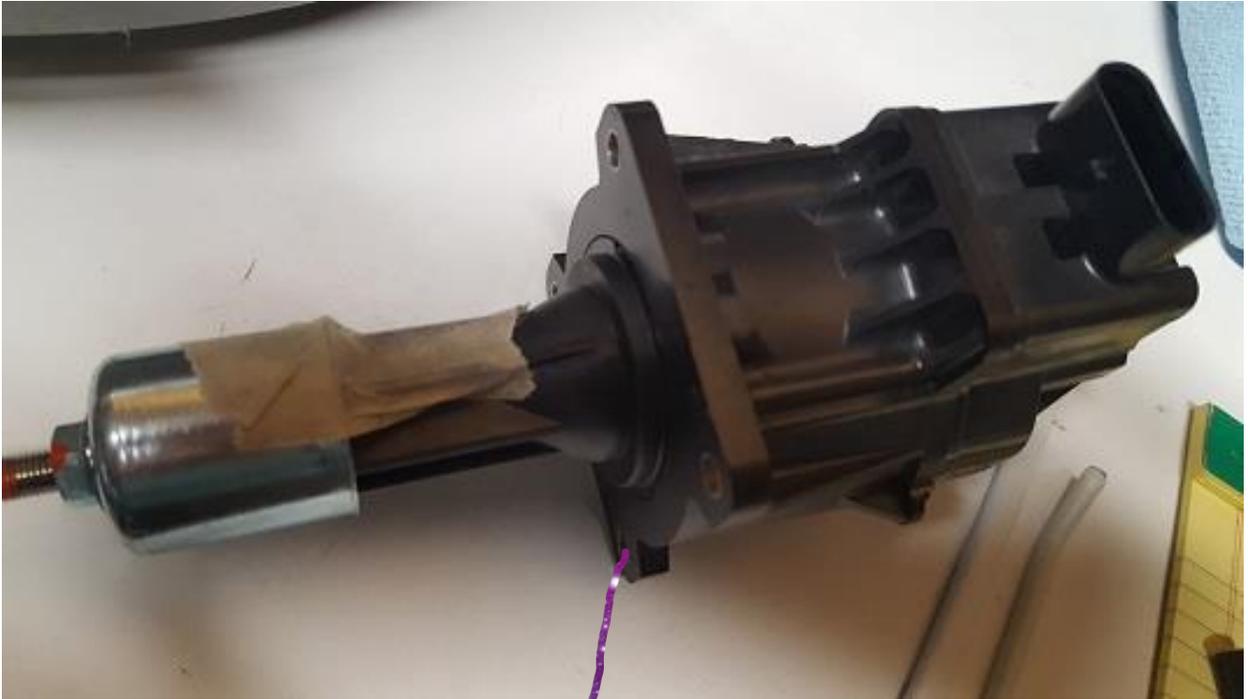
- Solenoid removed with tape preventing adjustment of the linkage (I think/hope). Metal cylinder will spin around.

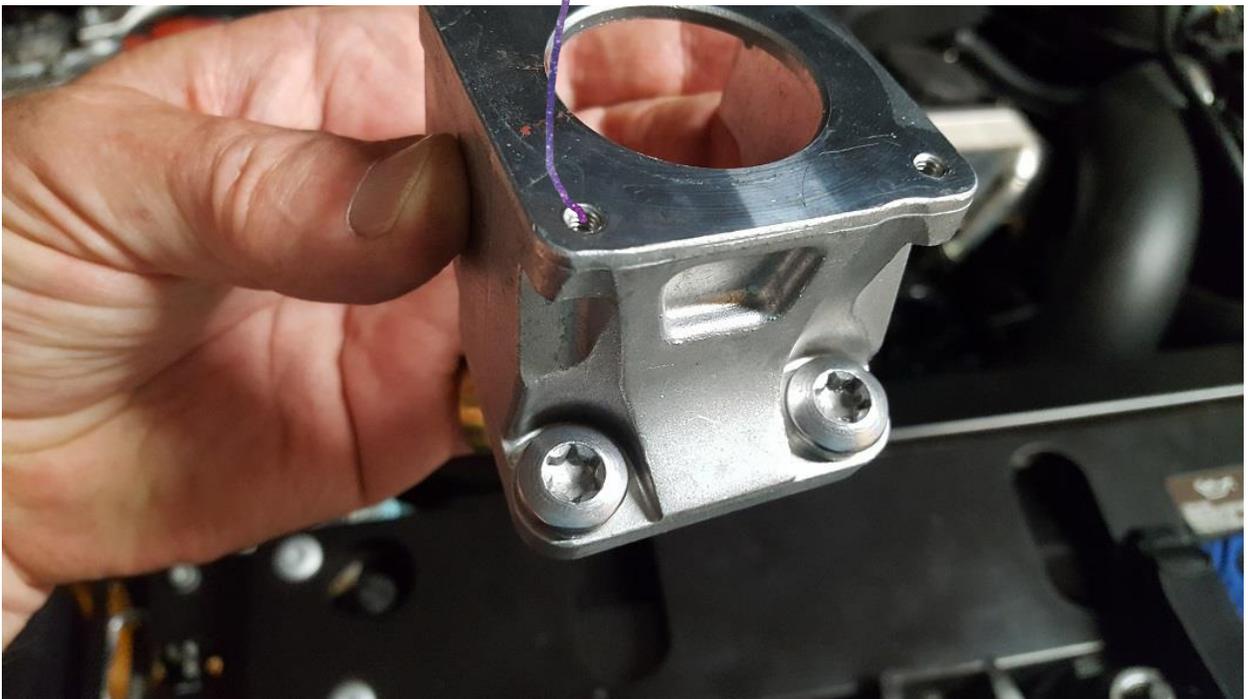
Aluminum holder removed to show position of the two T40 bolts underneath. Torque to 20NM when installing. The smaller holes are for the Philips screws.

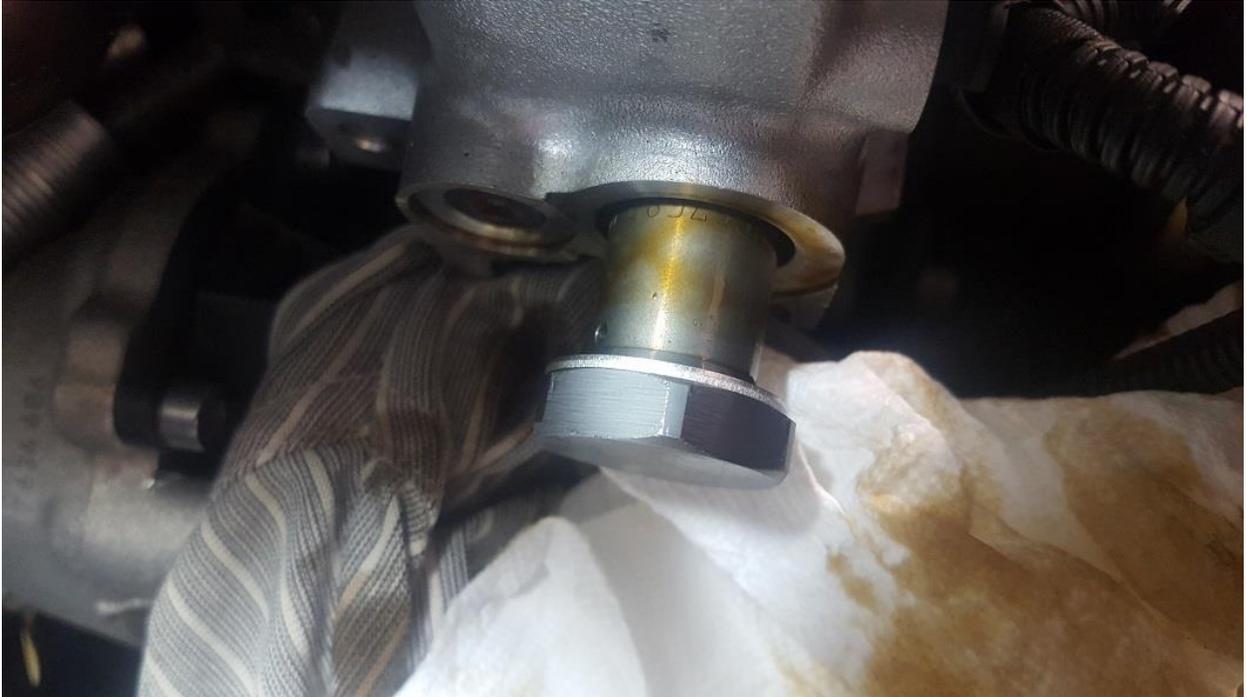
With the aluminum holder out of the way, you can now unscrew the tensioner – 27mm head. About a tablespoon of oil will come out. Have cloth underneath to catch. Torque new tensioner to 80 NM.

Getting the thread to catch on the new tensioner took a bit of unexpected effort. You must press in the tensioner as you turn it by hand. With the new stiffer spring, that took a few tries.
