Ceramic Knob Retrofit & IHKA Button Replacement

F07 – GT

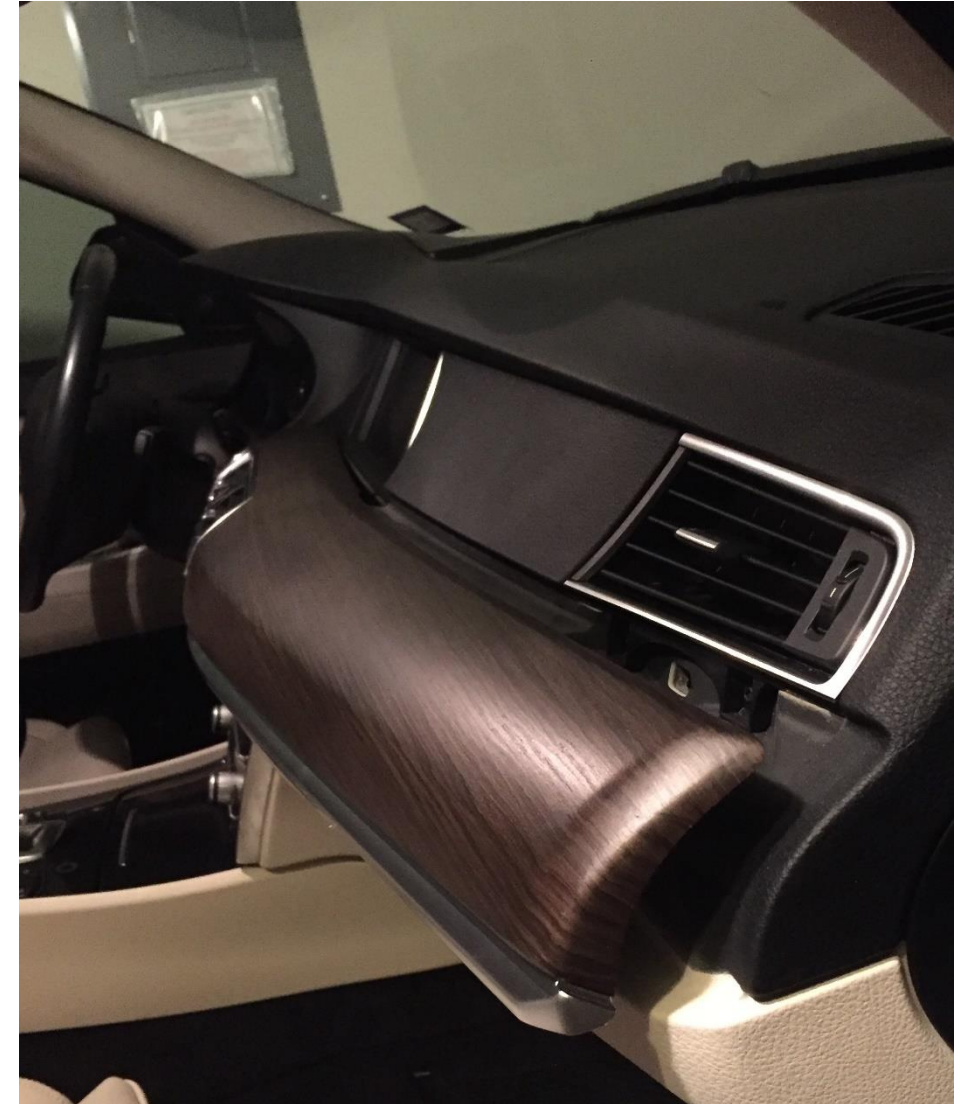
Trim Removal - Instrument Panel Décor Cover

- Removal same as F01 – Begin from Passenger Side
 - 4 Clips Spaced between Center & Right Vents
 - 2 Clips Near Start/Stop Button

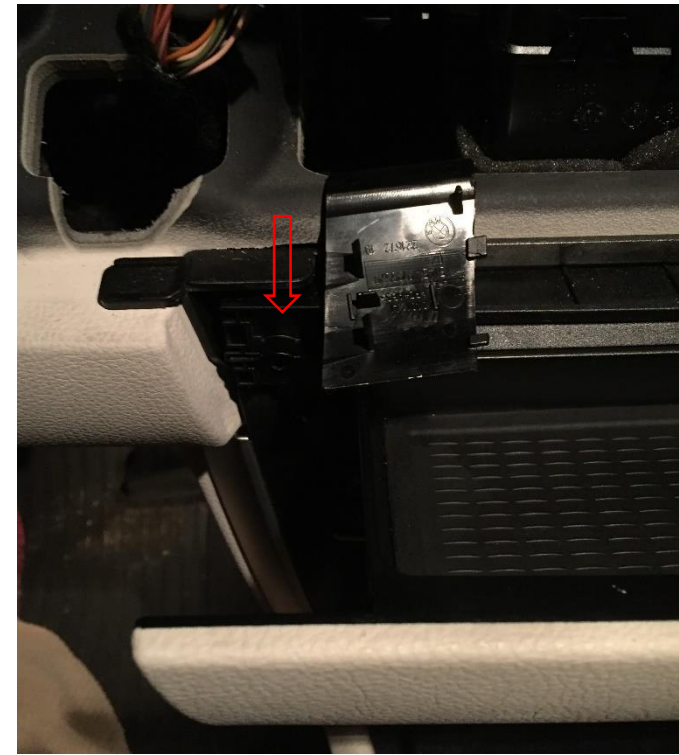
Trim Removal - Center Tray Removal

- F07 Unique Feature!
- Open Tray
 - Unclip black faceplates on right/left
 - Unscrew the T20 torx screws hidden by faceplates*
 - Indicated by Red Arrow

Upon further review I believe it may be possible to pop off the black faceplates from the bottom...if that can be accomplished, you do not have to detach the wood trim

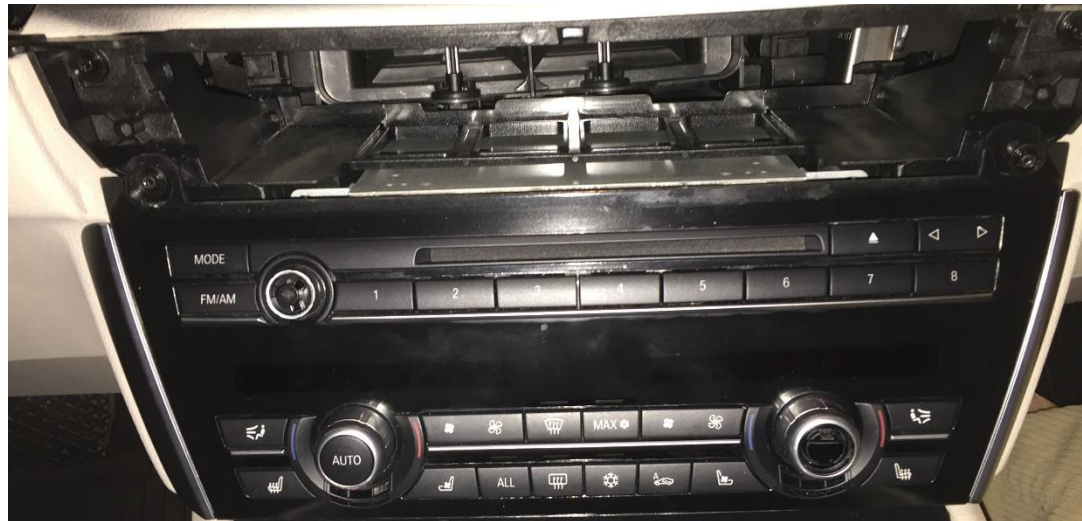
- Remove Tray to Access Top of IHKA Panel

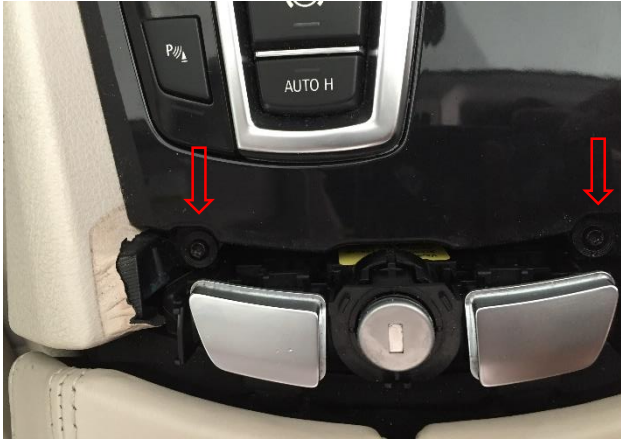
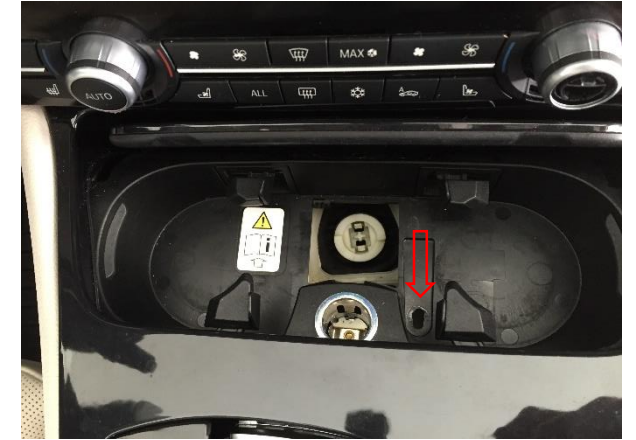
Trim Removal - Center Console Trim Removal

- Remove Center Console Cover
 - Reveals 2 T20 Torx Screws - Unscrew
- Pull Out Cup Holder Rubber Insert
 - Reveals 1 T20 Torx Screw - Unscrew
- Lift Console from Rear
 - Detach Clips (left/right near cup holders)
 - Unlatch electrical harnesses for:
 - iDrive Controller
 - Driving Mode Buttons
 - Parking Sensor Button (if applicable)*
 - Lighter Socket

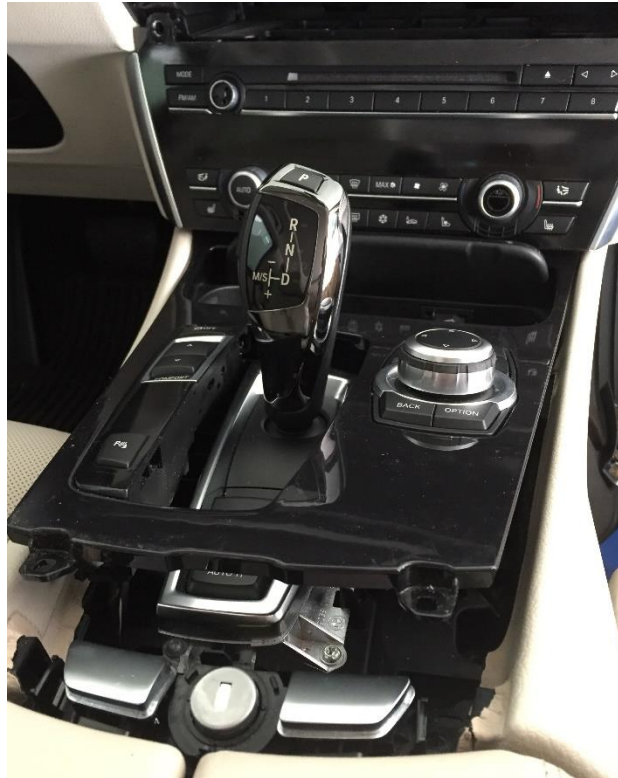
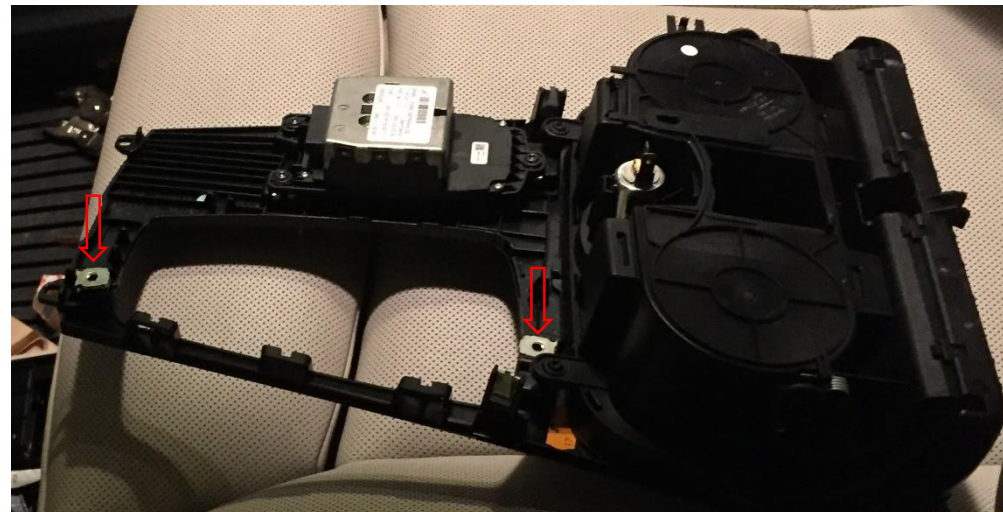
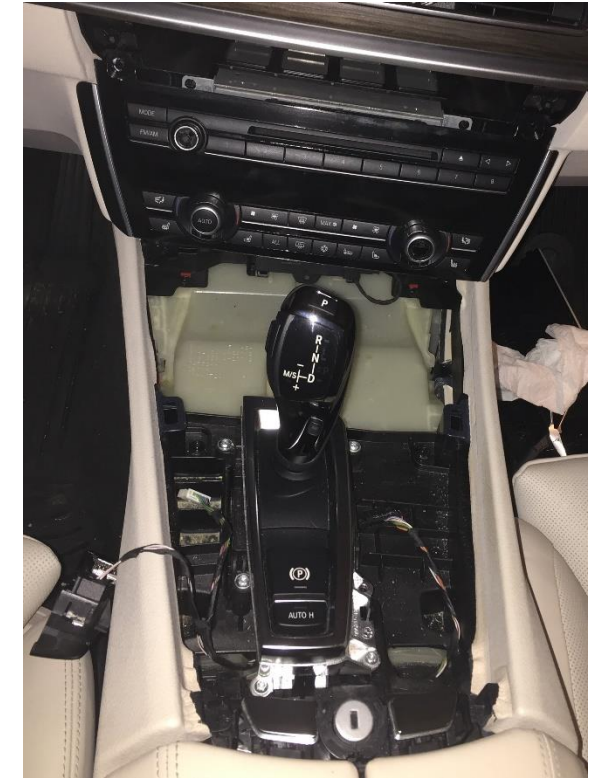
*Note: The parking sensor electrical harness proved difficult for me as it was so small I couldn't gain leverage to remove. Instead I detached the cluster that contains both the parking sensor and driving mode buttons from underneath (see picture below for location). Using a 1/4" socket wrench worked best due to tight working space.

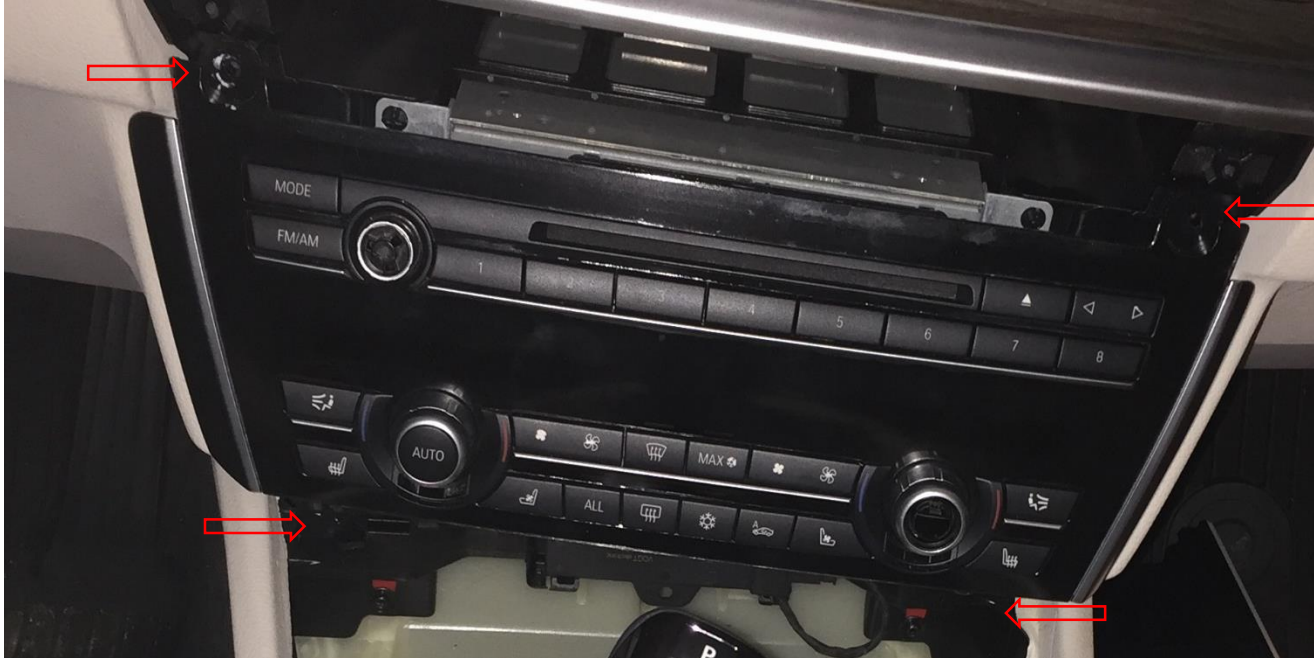
Trim Removal - IHKA Removal

- Four T20 Torx Screws Hold the IHKA in Place (Red Arrows)

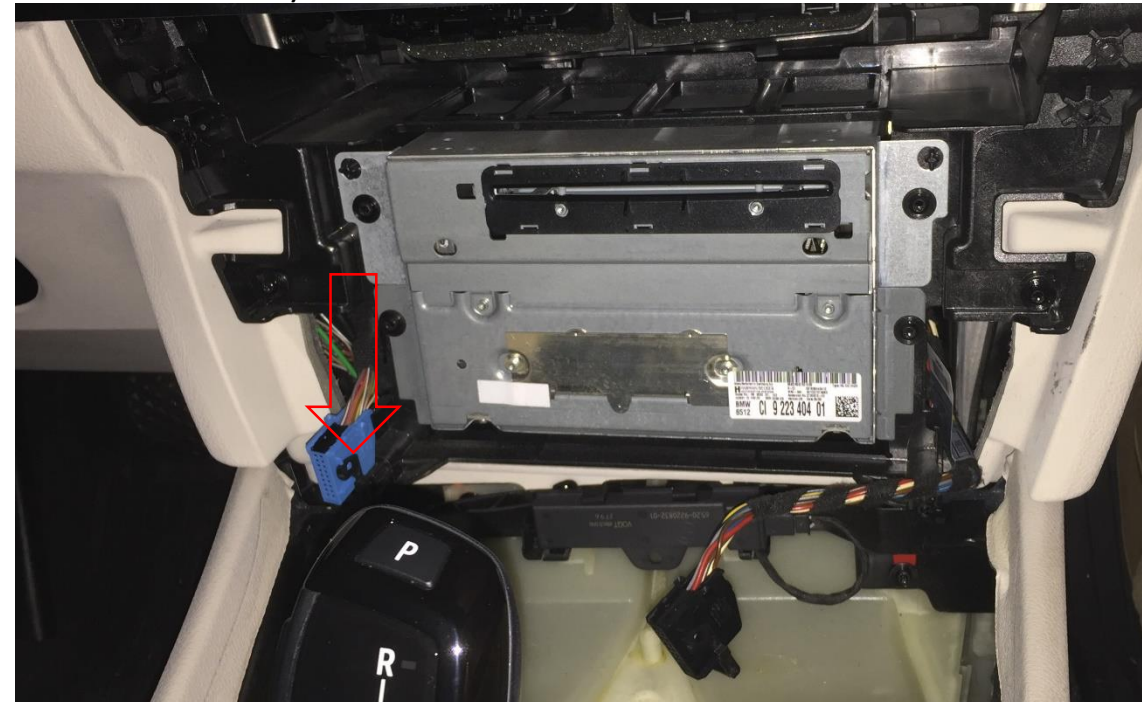
- Detach Electrical Harnesses
 - There are 3 Ridges that hold the Handle in place, depress them to Swing the Handle Down (Arrow shows handle)

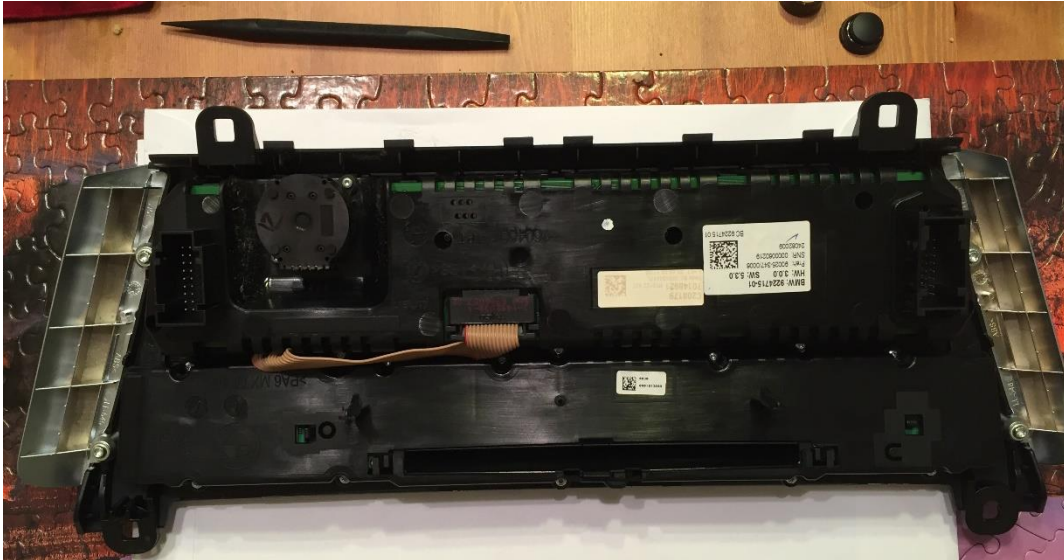
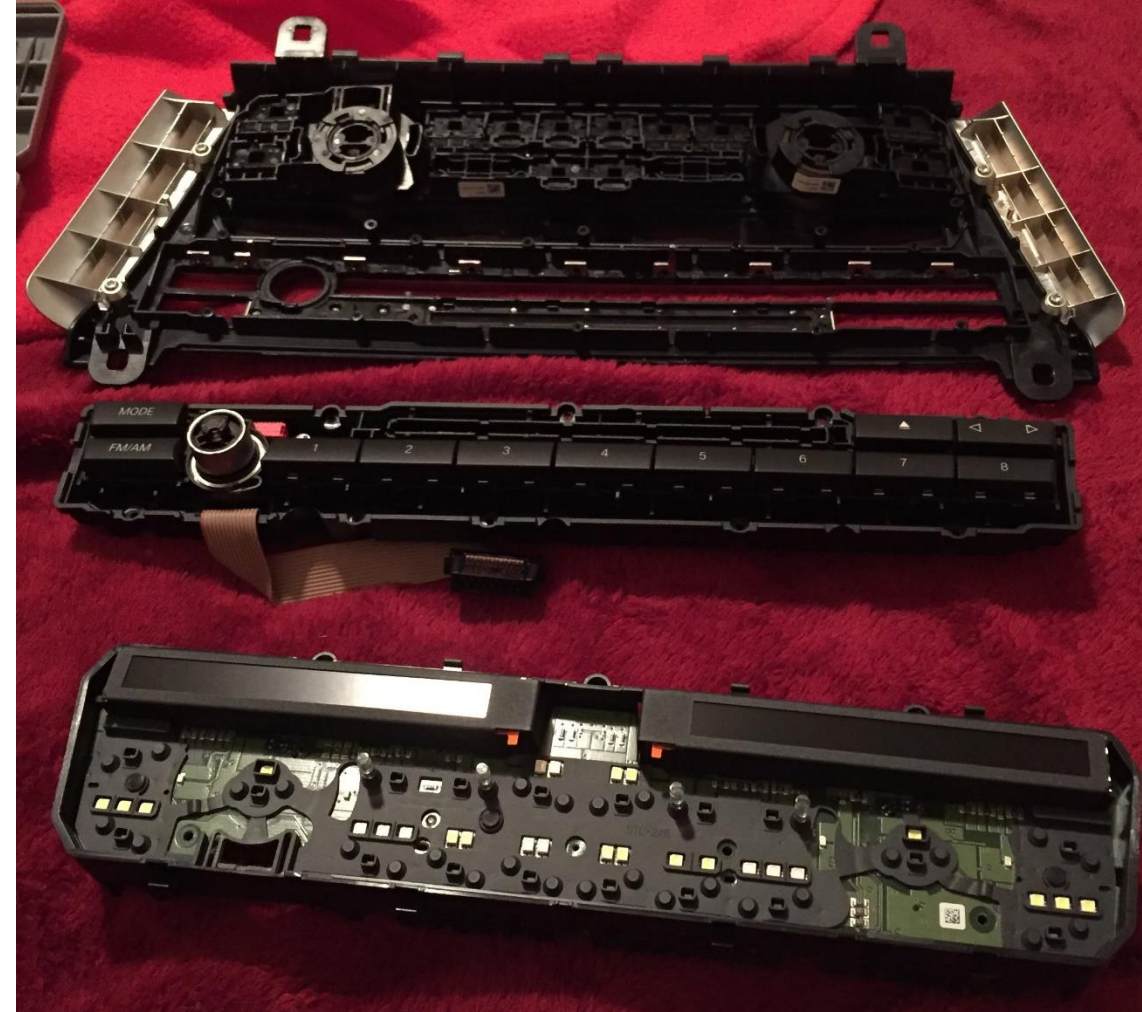
- Disassemble IHKA Panel
 - Disengage Electrical Ribbon Harness
 - Unscrew A/C Panel (T6 torx)
 - Optional (but recommended): Unscrew Temp Sensor Fan*
 - I would not detach the radio panel – it is unnecessary for radio knob removal/replacement

From Top to Bottom: Radio & A/C FacePlate with button assemblies still in place

Radio Control Panel

A/C Control Panel

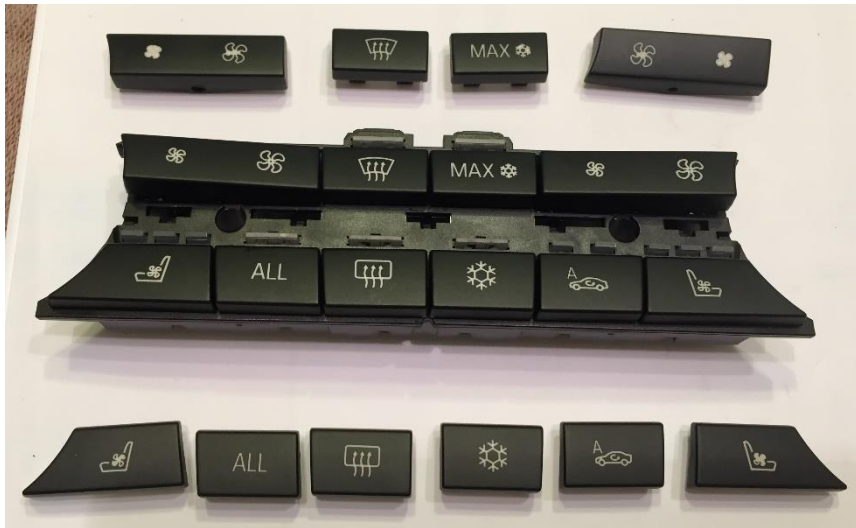
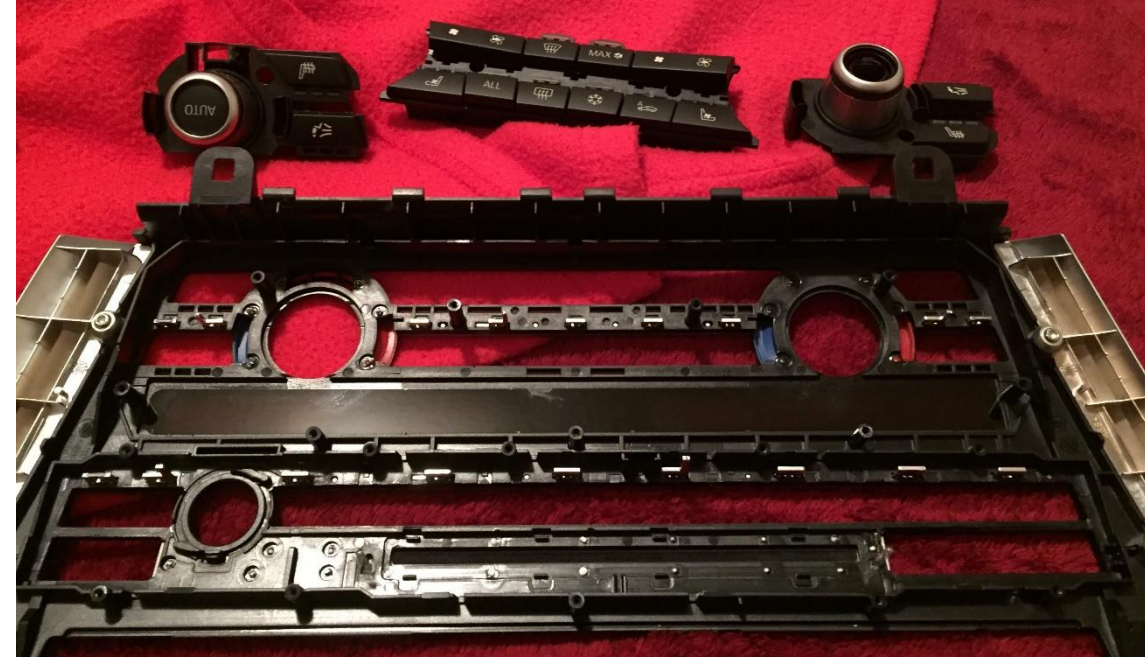
- Disassembled IHKA Panel (Right)
 - Button assemblies at top are not held in place via any locking mechanism
- Old vs New Buttons (Below)
 - Small tabs hold the buttons on, they are easily pried free

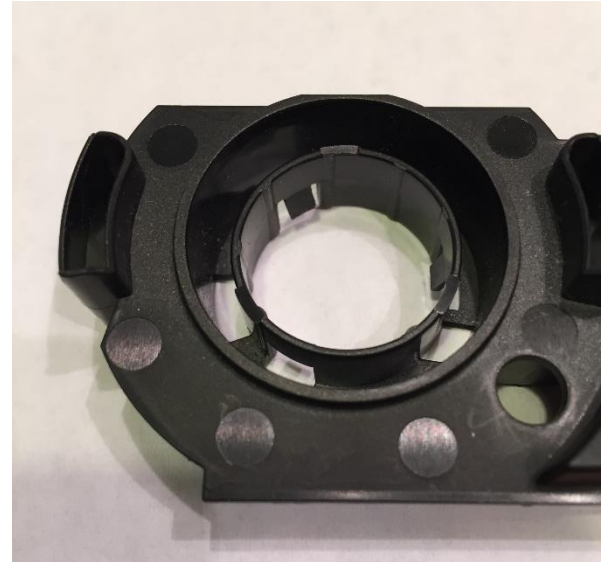
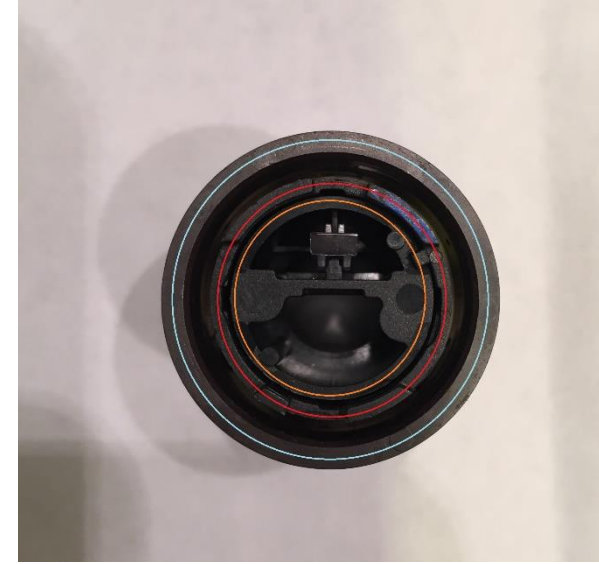
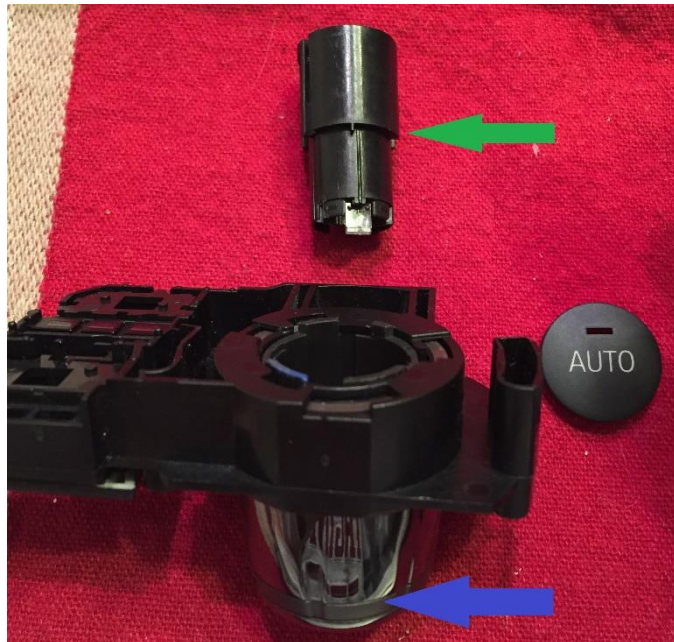
- A/C Component with Knob Removed (Near Right)
 - Note the tabs (there are three spaced 120° apart)
- Rear of Knob View (Far Right)
 - The red circle has three depressions that match with the tabs mentioned above
 - One of these is accessible via a hole in the red ring after the center piece is removed (as shown below)
 - I suggest using a tool with an angled end to lift up one of the other tabs, with both tabs released the knob slides out with minimal effort.
 - The blue ring rotates freely and the orange ring is the piece indicated by the green arrow in the lowest photo

By removing the AUTO faceplate the center piece slides out the back. It cannot come out the front even though you can pop off the front o-ring (blue arrow).

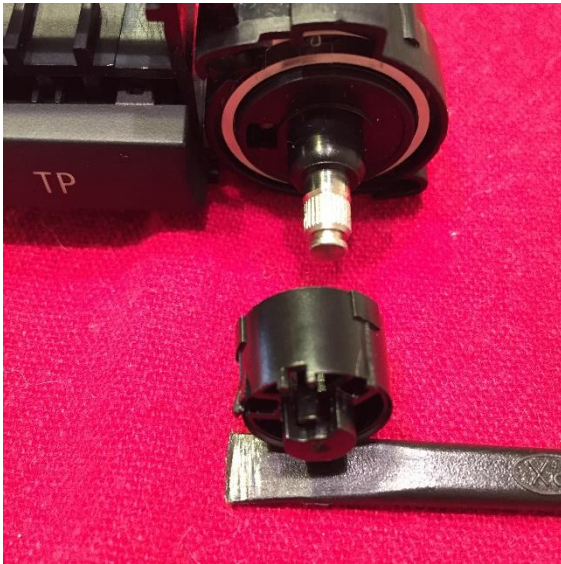
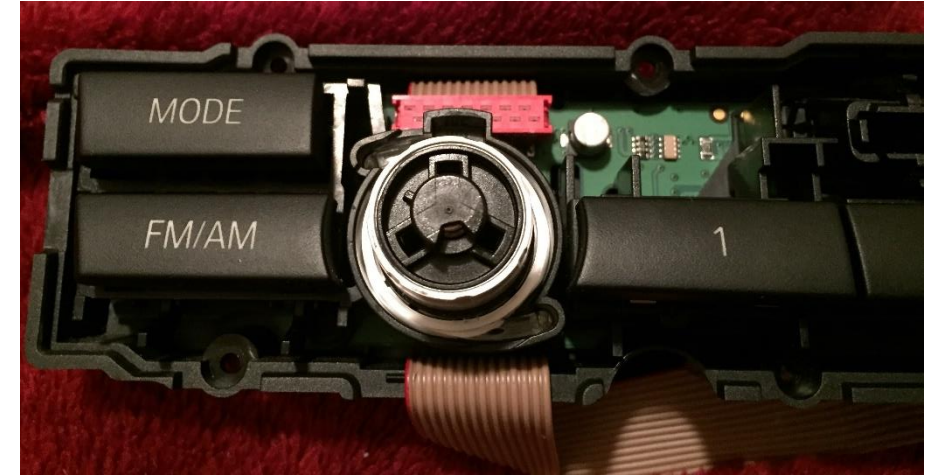
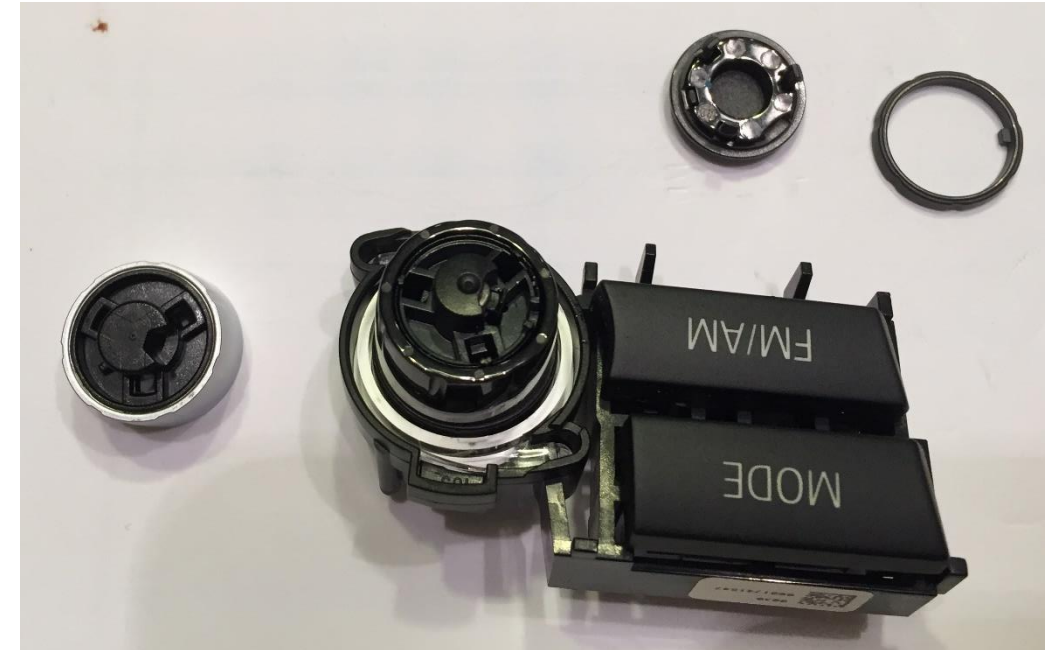
- Radio Knob

- The cap of the radio knob is easily pulled off by slipping your fingernails between the black o-ring and the “chrome” then pulling.
- The design of the caps are slightly different between the ceramic vs non-ceramic radio knobs so you must pull off the black plastic (as shown bottom left) that is slid onto the metal shaft.
 - This is visible in the lower right hand picture as noted by the inner plastic diameter is larger for the non-ceramic knob.
 - *Removing the radio panel will make this slightly easier, but not worth the hassle due to the touch sensitive knobs (1-8) possibility of not being correctly fitted/contacting the circuit board and causing unwanted activation of the memory storage function when driving*

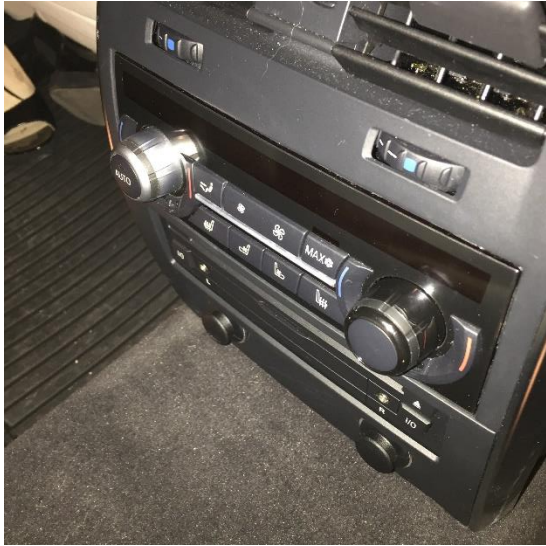
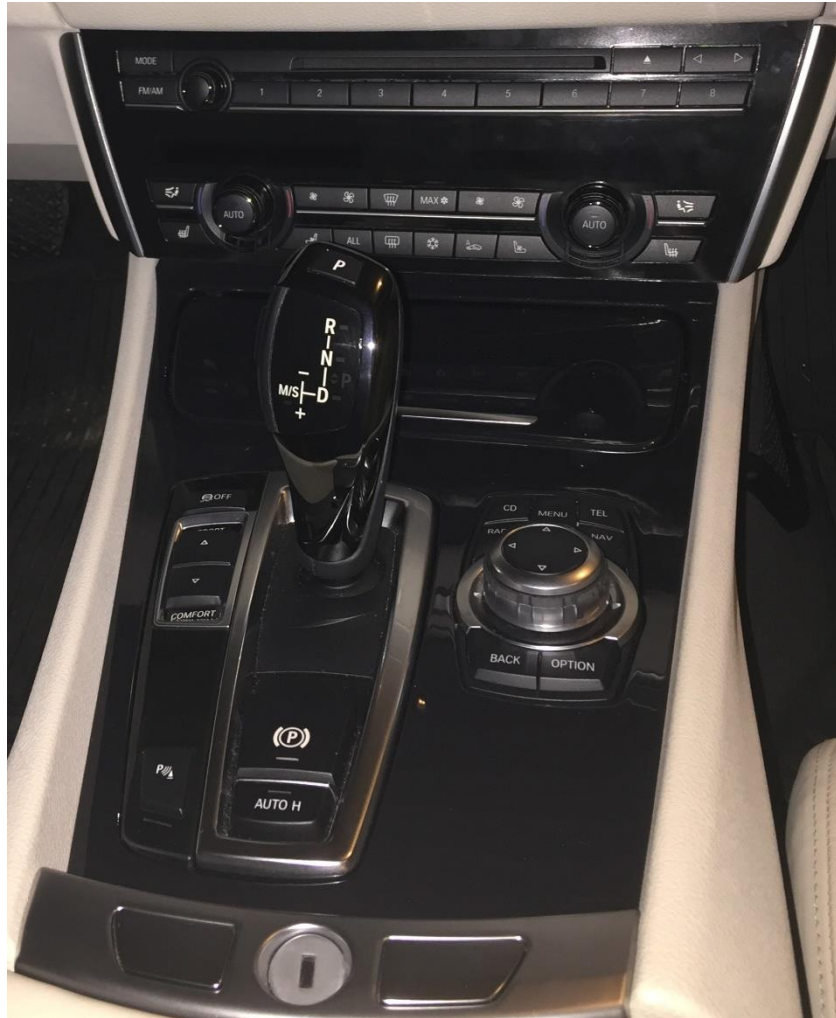
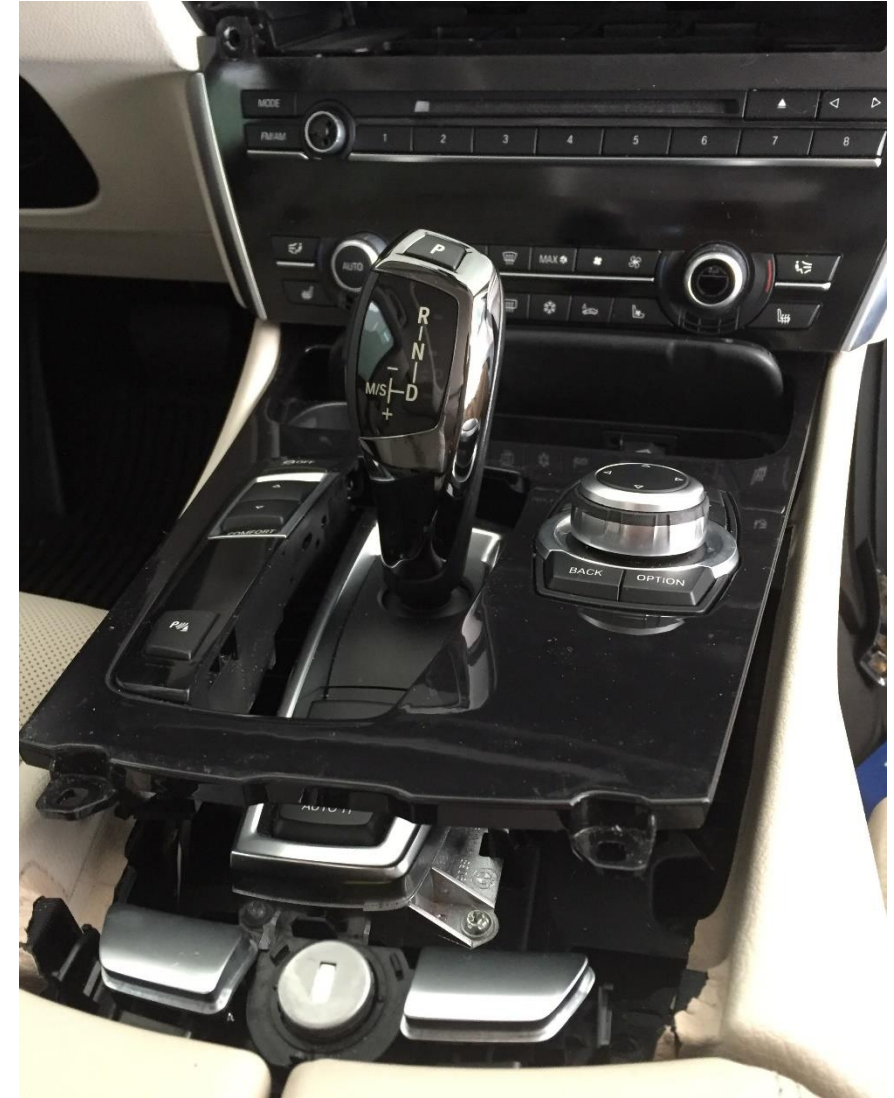
Reassemble and you are done!
