DIY Pulling and troubleshooting the ZF 6HP26 Mechatronics Unit E-shift Unit

pulled from various sources by Wilson009

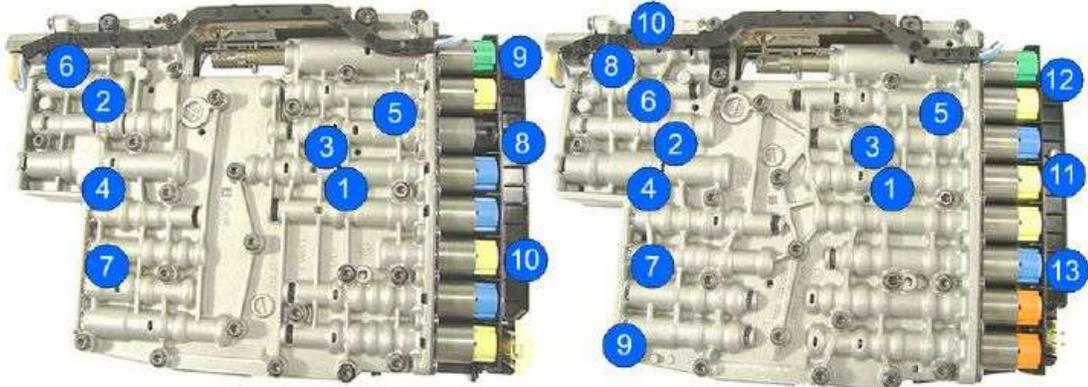
7

First install and turn screw 1 and 4 alternately until seated then install all other screws until they make contact with the mechatronic. After all screws are installed, tighten screws in order 1 through 10 or 1 through 13 as shown in the schematic below.

Torque for screws is $8 \text{ NM} \pm 0.8 \text{ Nm}$.

First install and turn screw 1 and 4 alternately until seated then install all other screws until they make contact with the mechatronic. After all screws are installed, tighten screws in order 1 through 10 or 1 through 13 as shown in the schematic below.
Torque for screws is $8 \text{ NM} \pm 0.8 \text{ Nm}$.

Figure 18 Use Pic on Left. Do not overtighten! 8nm

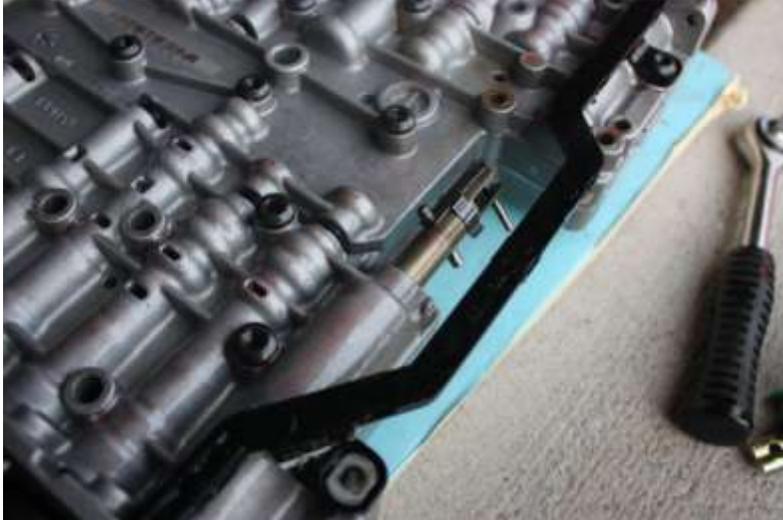
Figure 1 pic of Park Cylinder

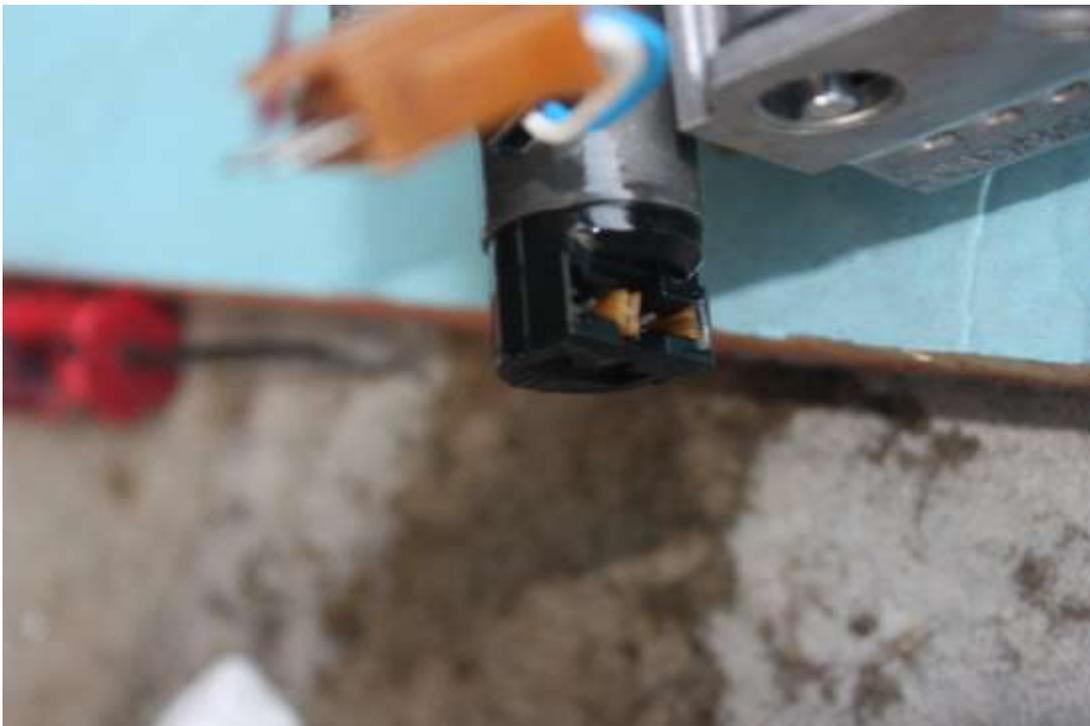
7. This is where I found my parking lock error. MV2 which is responsible for that and an open circuit or a reading of 1. I ordered a replacement from ZF distributor Errickson Industries for \$60 bucks. Excellent company very friendly. Contact is Nat www.erikssonindustries.com 800-388-4418 in CT. Had my package in 2 days. This fixed my Parking Lock errors.

Figure 2 Bad Solenoid also broke off plastic in there from harness. I think i did it while inspecting it.

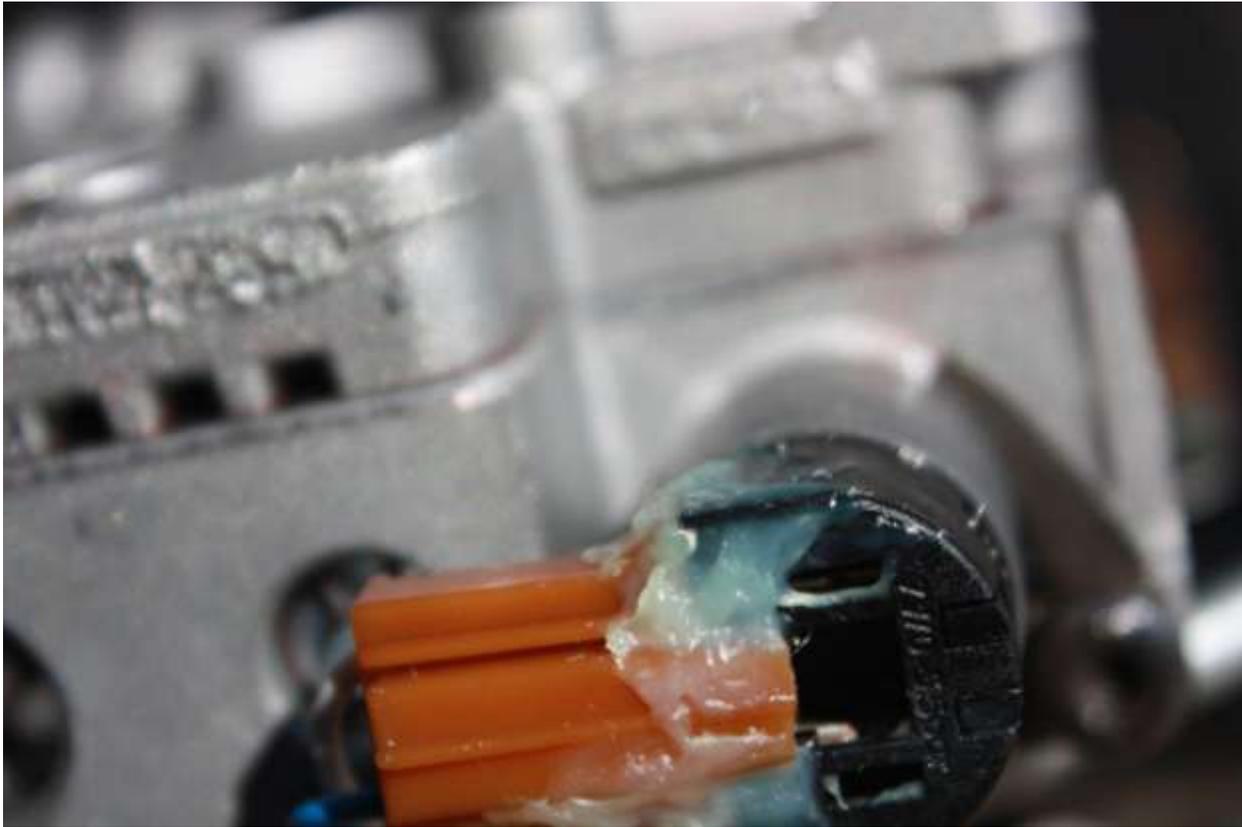
Figure 3 New Solenoid with Harness glued in tight.

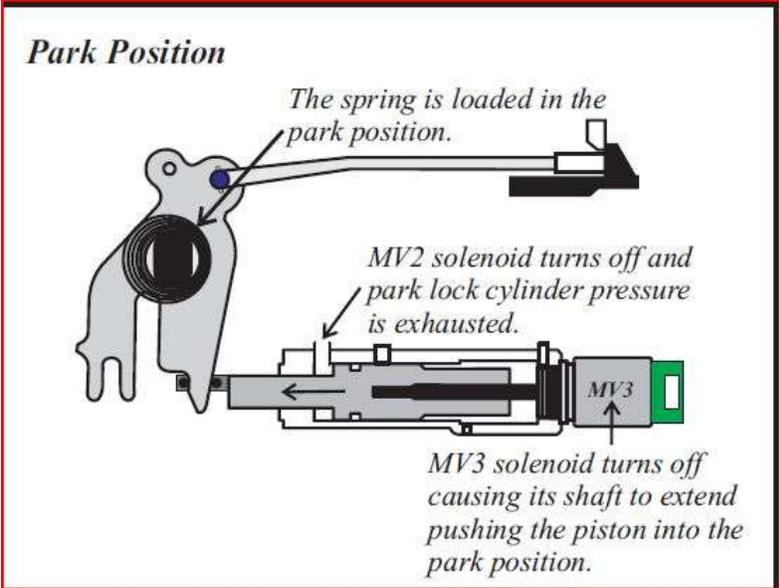
Figure 4 Shows MV2 Function which malfunctioned on my car

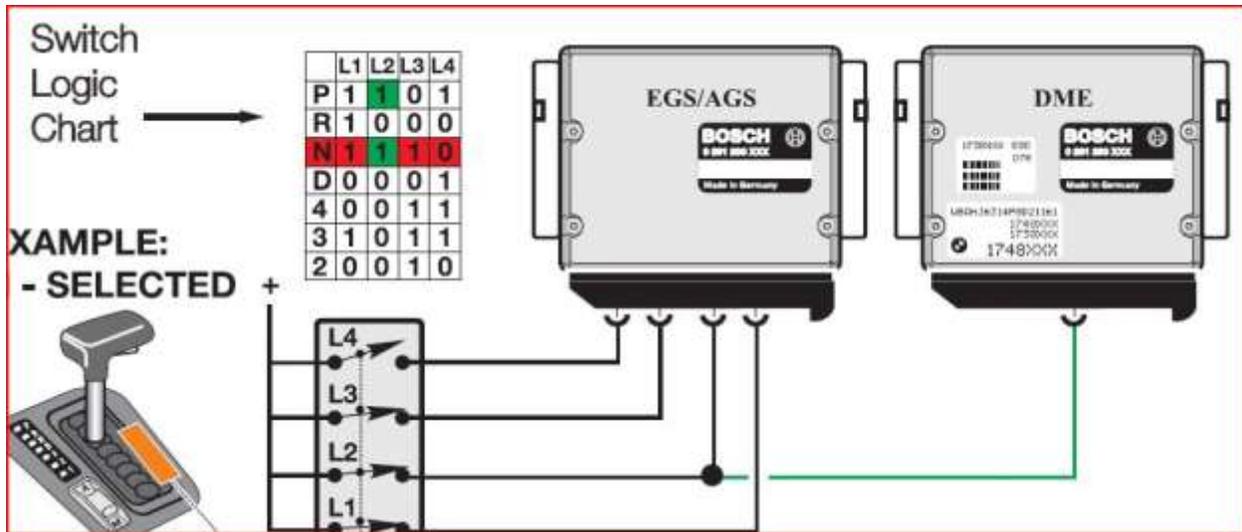
Figure 5 This caption shows how shifting is applied where L1 = EDS1 etc

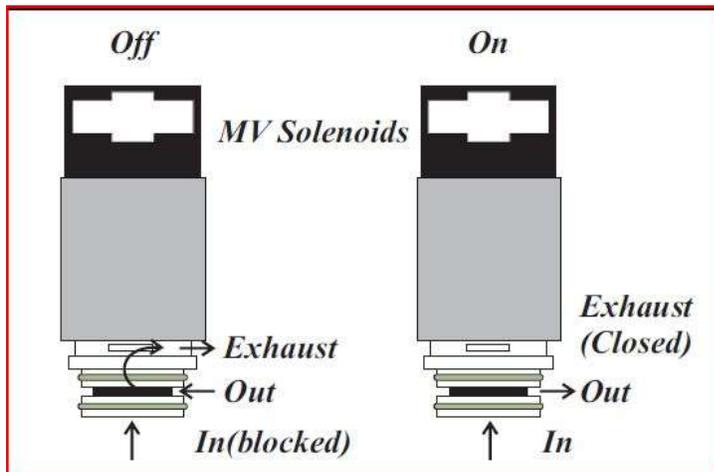
Magnetic Valve (Shift) Solenoids (MV). Controlled by a switched (on/off) power or ground signal from the TCM. The valves have two positions open or closed. Some are normally open and close when activated and some are normally closed and open when activated.

Figure 6 Functioning of MV Solenoids

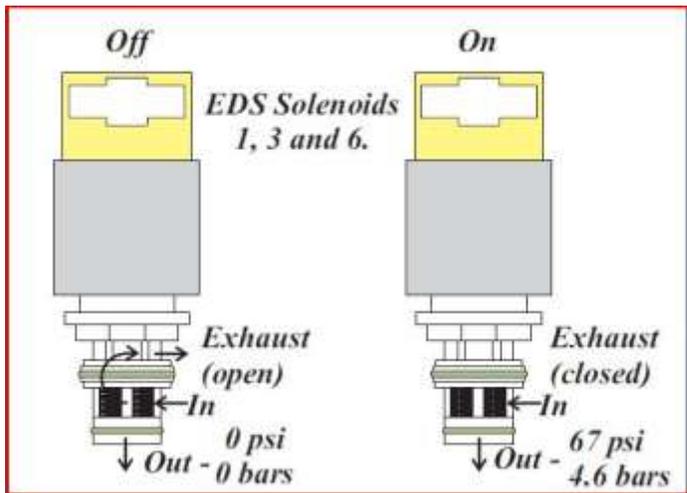
Figure 7 EDS 1 3 6

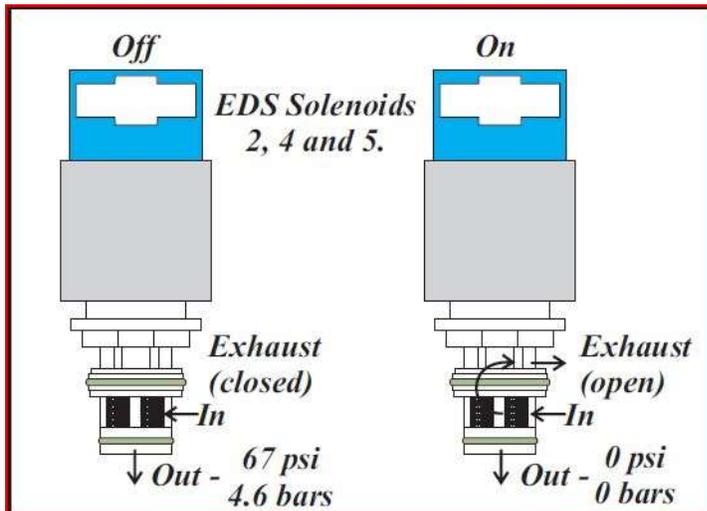
Figure 8 EDS 2 4 6

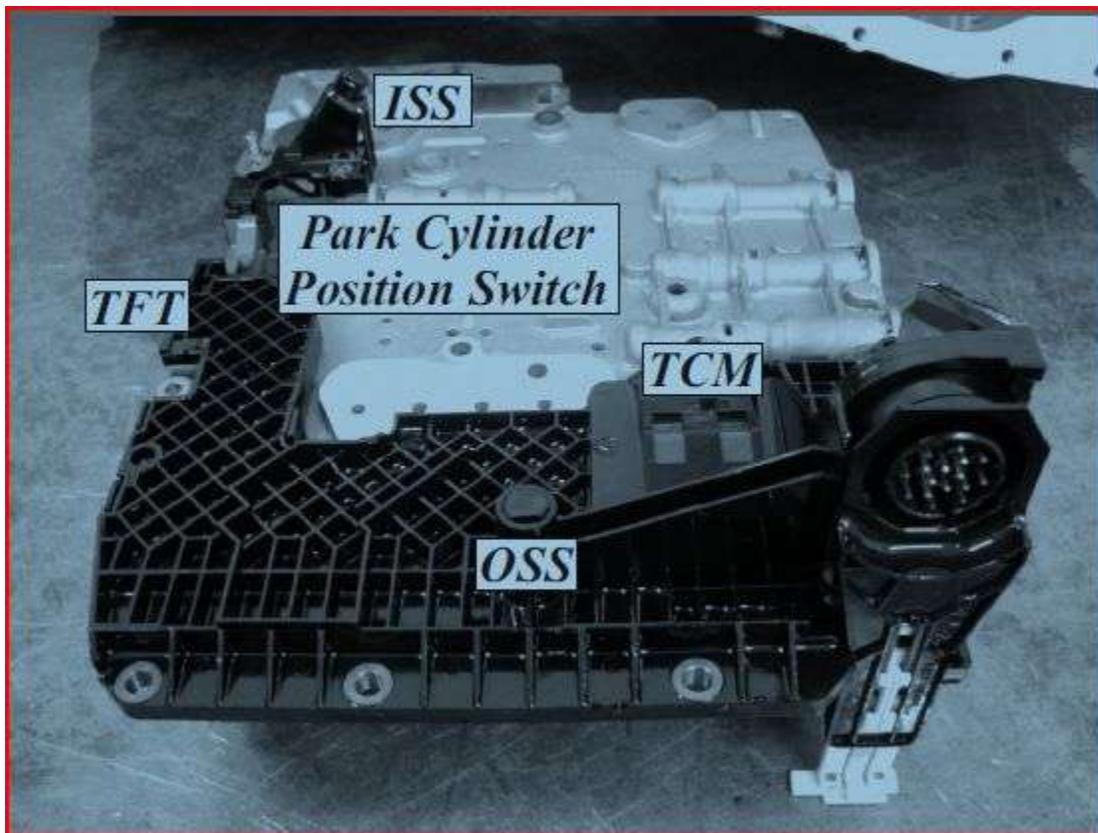
The mechatronics has a few crucial sensors on it.

ISS-- Turbine Speed Sensor This Analog inductive sensor produces an A/C sine wave similar to an ABS/ASC wheel speed sensor. The signal frequency is proportional to the rotation speed of the monitored component. The speed sensors are used to monitor clutch slip for plausibility and shift points as well as maintaining adaptive hydraulic pressures.

OSS-- Output Speed Sensors. The description of ISS applies to this as well

Park Cylinder Position Switch --Monitors the position of the Park Cylinder with E-version

TFT --Temperature Sensor This TFT resistor provides a variable voltage drop proportional to transmission oil temperature. The TFT is soldered into the oil temp circuit of the wiring harness located in the transmission oil sump.

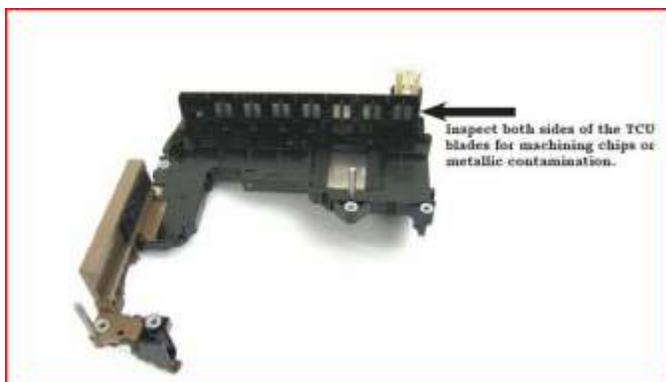
Figure 10 Spray and Clean and inspect for Cracks. This unit can also be opened

10. Remove the bolts that hold the valve body and the TCM together and carefully slide them apart. Any metal coating on these can mess up reading as well as impede contacts and signals. Now Clean the valve body and TCM. I used Paper Towels and Brake Cleaner and Qtips.

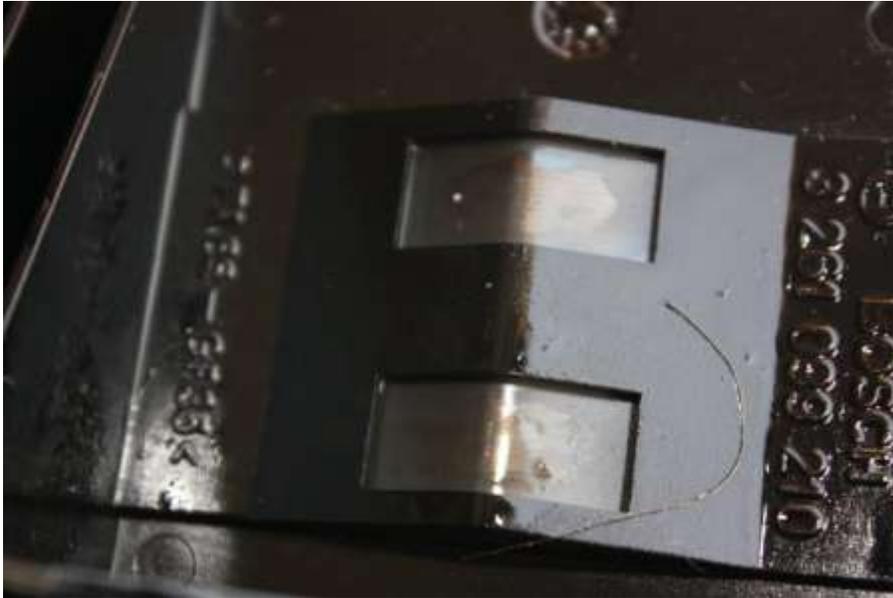
The ISS and OSS are used by the TCM and higher to calculate shifting ratios. If these sensors are impeded and give unexpected readings a gear ratio error will occur. . I also had notice a thin grey film on the valve body almost like anti-seize. Very fine metal.

Figure 11 Note Film on TCM These contacts are necessary for functioning

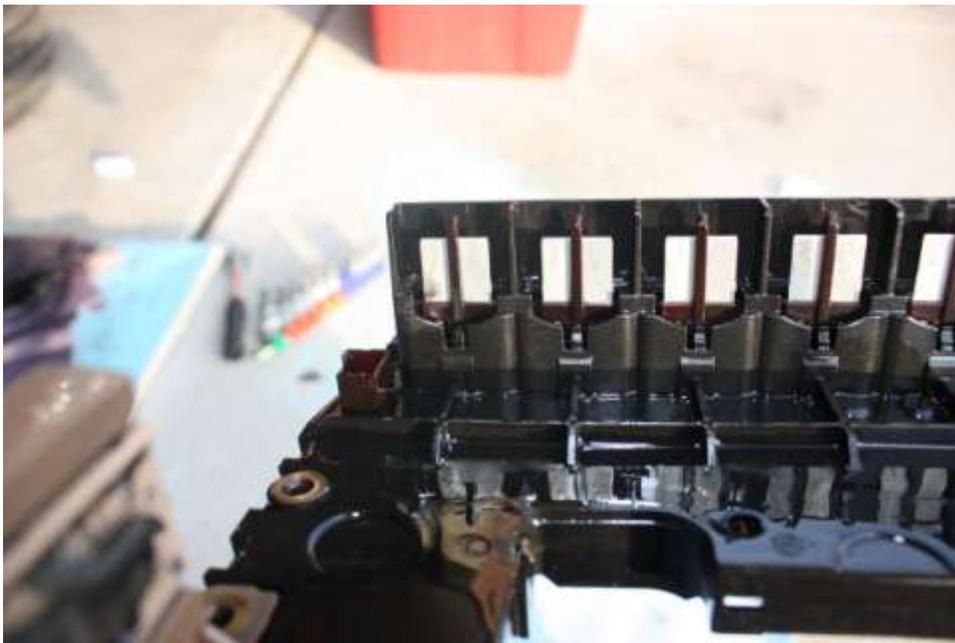
Figure 12 Clean all your contacts

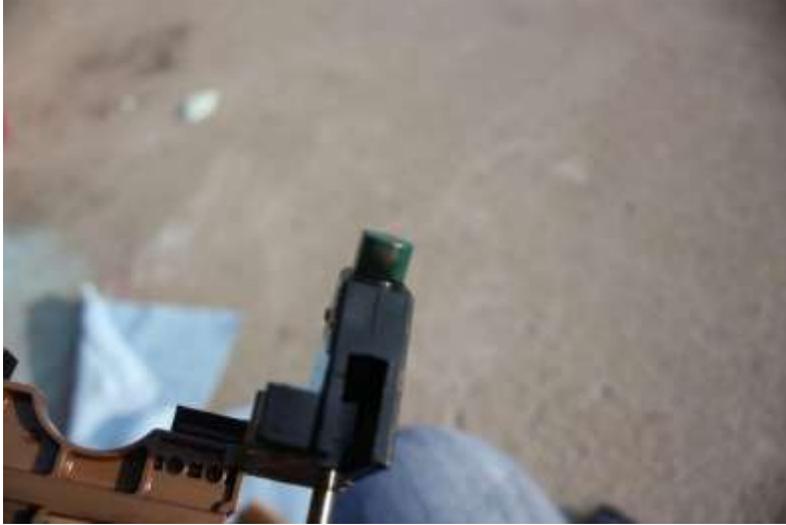
Figure 13 Take a look at this ISS Sensor. It is covered in Fine Metal which affects the readings! Clean it off

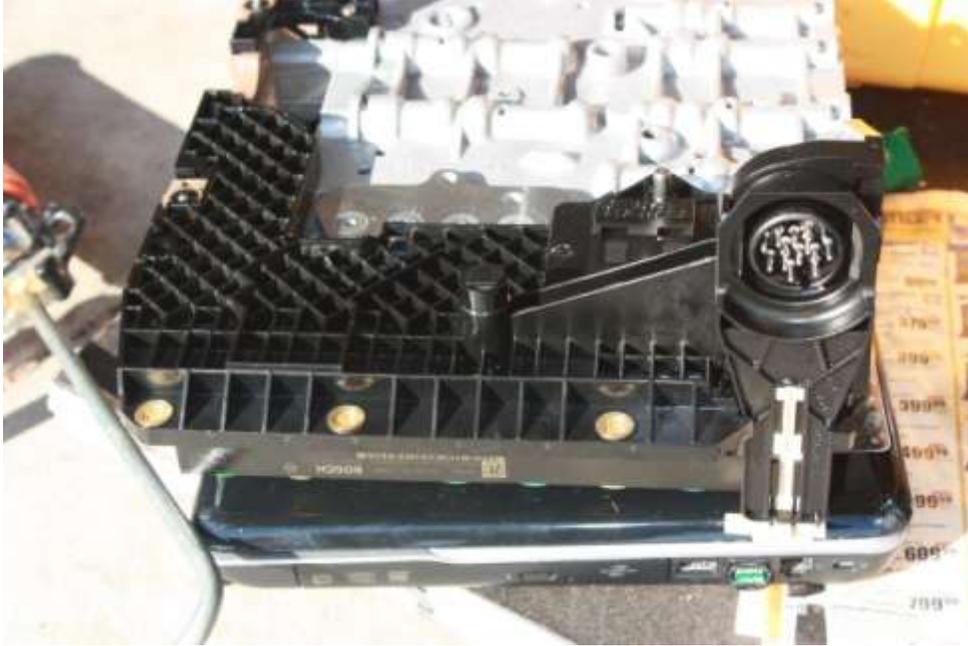
Figure 14 All Clean and back Together

11. Once everything is clean put it apply Foam Strip. Ordered form Erickson as well and torque to 8nm being careful not to over tighten.

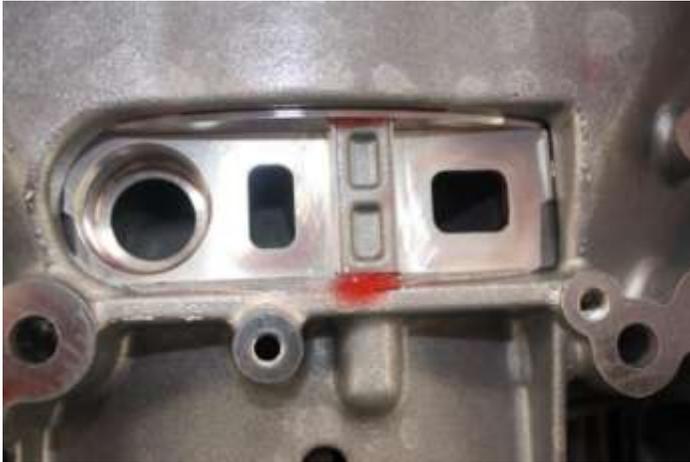
Figure 15 Bridge Seal adapter Fits Here. This seal is Prone to Cracking

12. Install the sealing Sleeves and Bridge Adapter

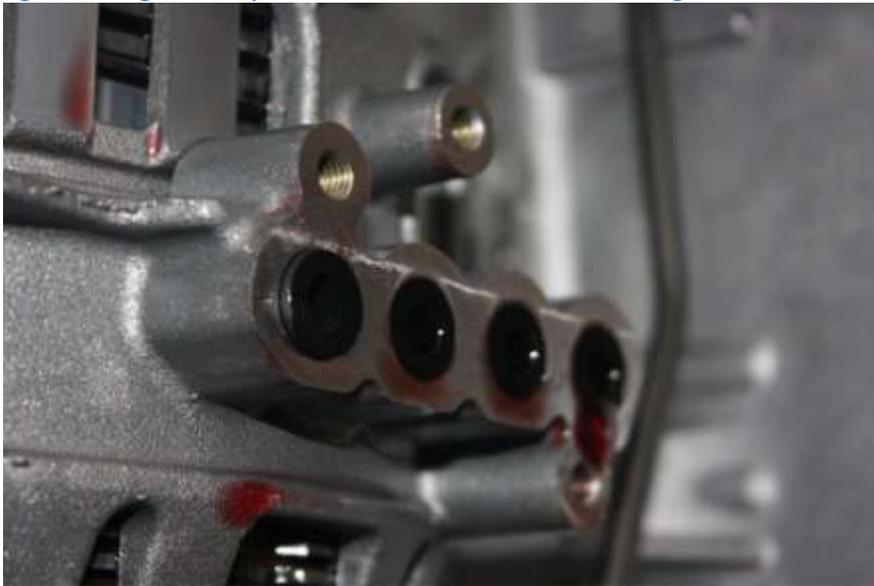
Figure 16 The 4 Sealing Sleeves Replace while its easy

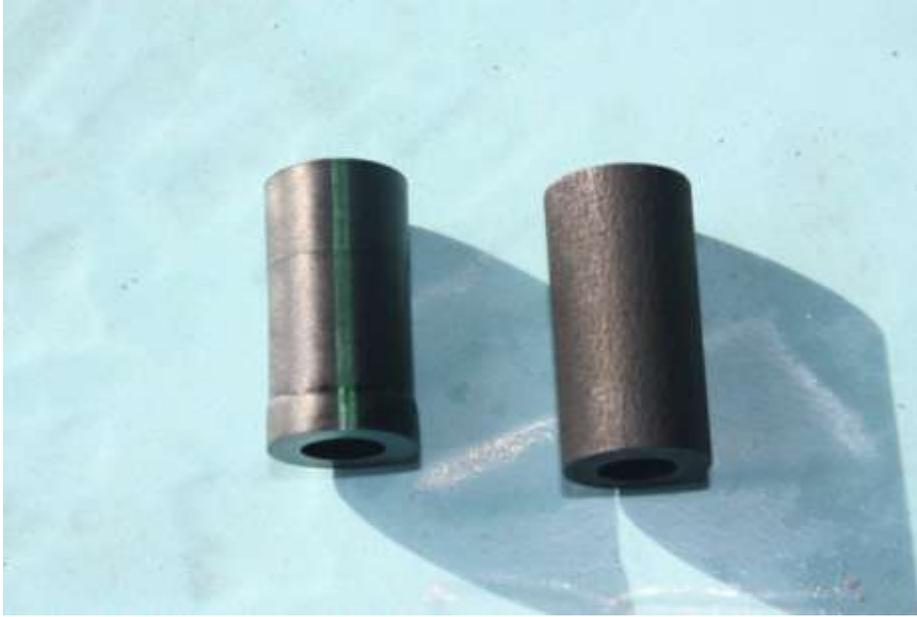
Figure 17 Old Sleeve Left New Right

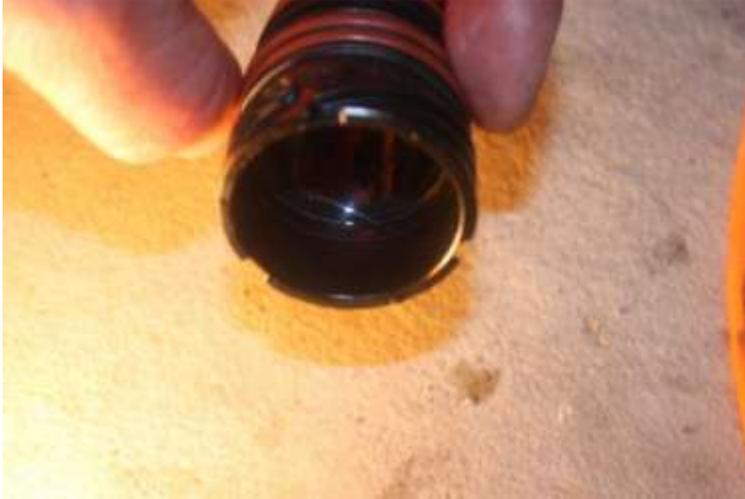
Figure 19 Mechronics Sealing Sleeve

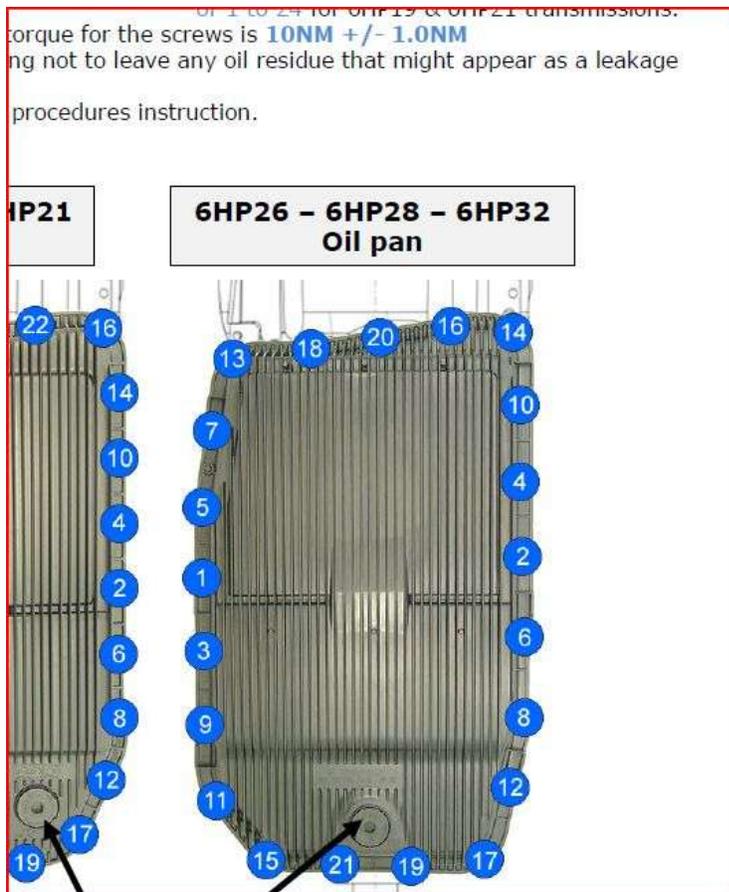
Figure 20 Follow the order started at 1. Tighten to 10nm

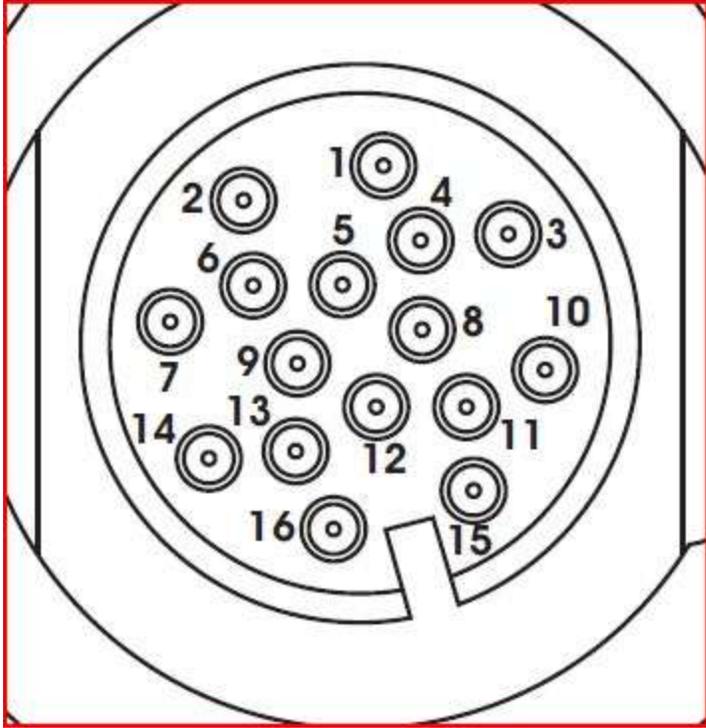
Figure 21 Mechtronic Adapter Pin locations
