BMW X3 - Rear window repair (driver side)

Step-by-step walkthrough

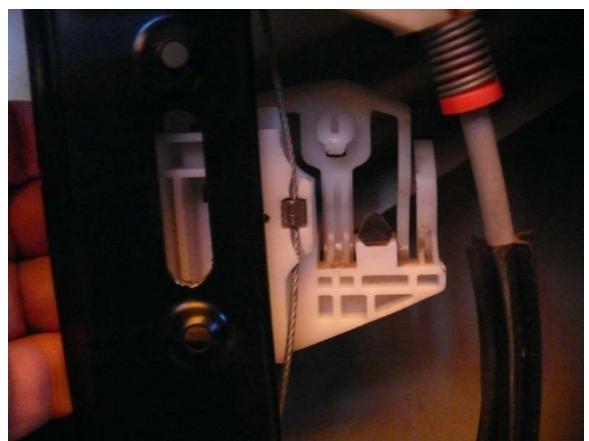
7) Review the drive dog to check for damage. In my case, the damage was very small, at the top of the space where the cable is fixed.
